Repair Report

County Ditch No. 23

Le Sueur County, Minnesota

ISG Project No.: 17-20141

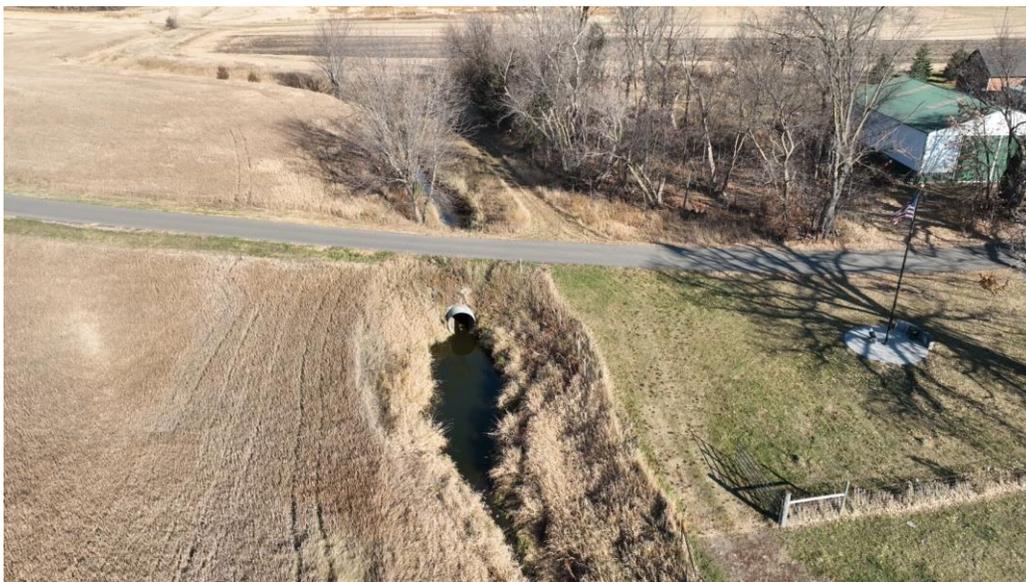
Recent repairs have been completed on the system. In 2021, there was replacement of a couple of culverts and armoring for erosion protection. Additionally, there was repair work completed in 2022 which included bank repairs and armoring of Crossing #13.

Figure 1: Crossing #13 prior to 2022 repairs to sloughing and erosion protection

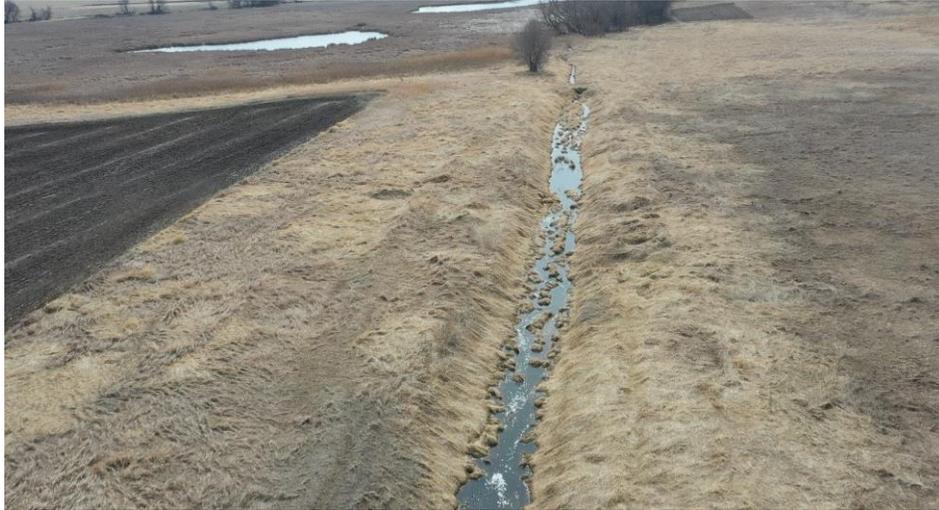
A review of the cross-sections in the repair plans indicates that the existing ditch bottom widths and side slopes vary widely due to sedimentation and side slope damage. When the existing and legal profiles are compared, sediment accumulation on average is 0.5-feet with areas identified up to 2-feet above legal grade.

Deposited sediment provides an opportunity for vegetation growth in the bottom of the channel. The effects of vegetation in the ditch vary depending on the type present. Sediment, grasses, and cattails in the ditch bottom can impede water flow leading to localized flooding during storm events. Sediment deposits along with vegetation growth can cause the ditch to meander potentially eroding side slopes.

Figure 2: Sediment and vegetation growth in center Spur 2 open ditch at Sta. 105+00

For ditch systems like CD 23, cleaning is recommended every 8 to 10 years. The topographic survey revealed that a majority of the ditch has accumulated sediment in the channel bottom above the ACSIC grade. The accumulated sediment has led to vegetation growth. It has also caused the flow channel to meander causing slope erosion.

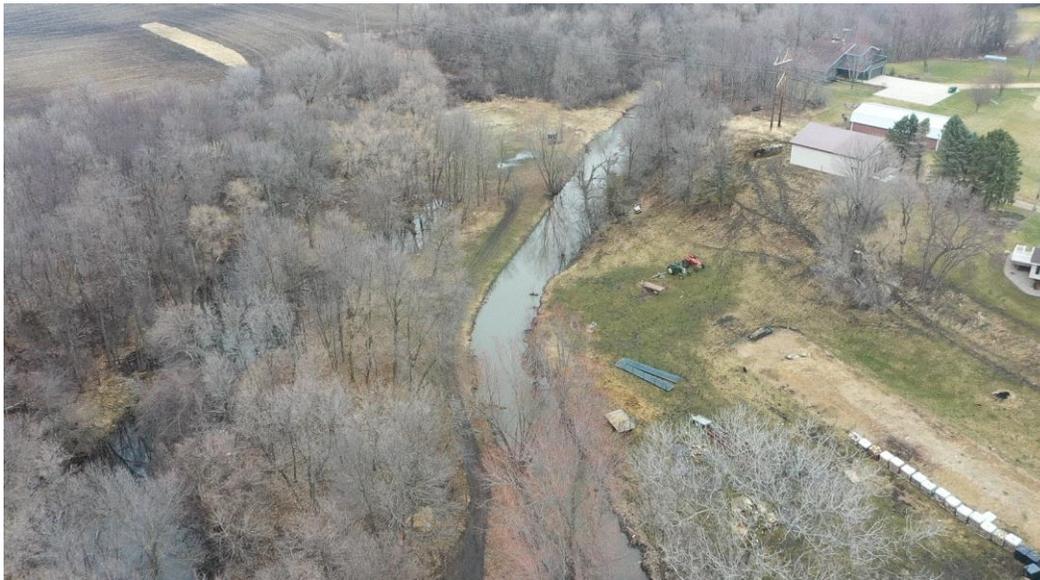
Trees and shrubs growing in or falling into a ditch restrict flow. The trees also provide a canopy across ditch banks and buffers creating poor conditions for grasses and other native vegetation in the buffer to grow. This makes the ditch more susceptible to erosion. Perennial grass along the ditch bank and on side slopes provides dense root growth, creating stable banks and reducing erosion. The following photos show examples of tree and shrub in the open ditch or within the 16.5-foot buffer.

Figure 5: Trees and brush on ditch banks and in buffer area on the Mainline open ditch at Sta. 3+00

Trees, brush, and shrubs were identified along the banks of the ditches throughout the watershed. To prevent future erosion of the ditch banks the present repair will include removing these obstructions. Areas where cleaning is to take place, vegetation and trees will need to be removed in order to access the ditch.

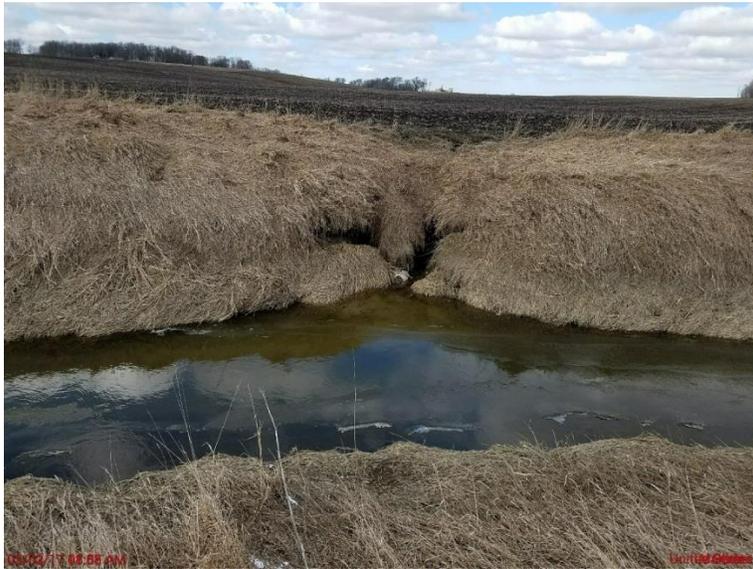
Many tile outlets within the open ditch are failing and causing or have the potential to cause erosion. Examples of failing tile outlets would include bent, broken, covered, crushed, or completely washed away tile outlets. Almost all tile outlets do not have riprap to protect the ditch banks.

Figure 8: Erosion at tile outlet

All tile outlets that enter a public open ditch may be considered for replacement or repair. Some of the tile outlets are in good shape and only require riprap protection. However, some tiles are bent, broken, or completely washed away causing erosion to the ditch banks. The repair of a damaged tile outlet will consist of replacing it with a section of new tile and placing riprap protection per the detail found in the Preliminary Repair Plans.

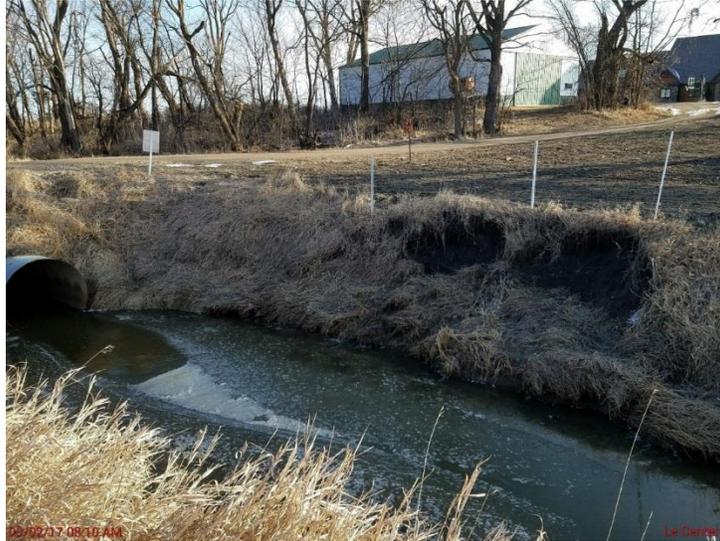
Sloughing was identified at various locations along the ditch. Sloughing occurs when the bank of a ditch shears and collapses into the ditch. The main causes of sloughing include overland flow overtopping the ditch bank, lack of buffer vegetation, steep side slopes, and meandering of the ditch. When sloughing occurs, it deposits sediment in the ditch restricting flow. Sloughing was identified at various locations along the ditches in CD 23. The figures below show areas of sloughing.

Figure 10: Sloughing on Mainline open ditch in NW ¼ SW ¼ of Section 23 of Lexington Township

The drone and topographic survey revealed significant ditch slope sloughing and erosion throughout the entire ditch system. Slough repairs included restoring the bank's side slope and stabilizing with erosion control blanket, mulch, or riprap. In some locations dewatering the side slope may be necessary to stabilize and may be necessary to include toe drains. Areas will be determined during construction.

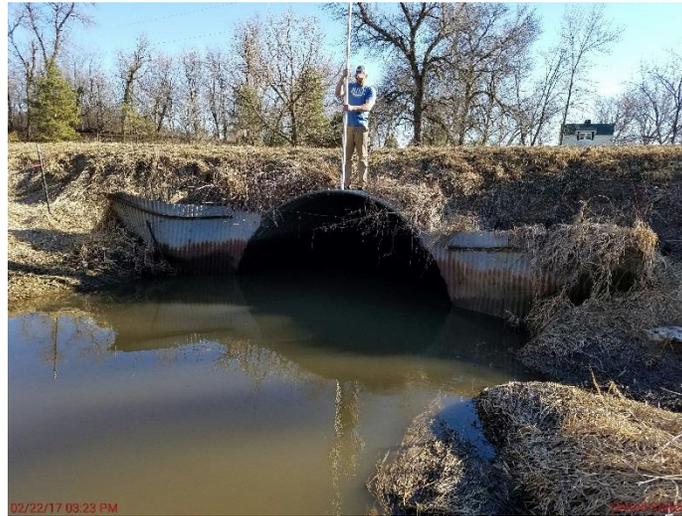
Figure 15: Outlet of CD 23. Erosion around 102-inch culvert at West Prairie Street (Crossing #1)

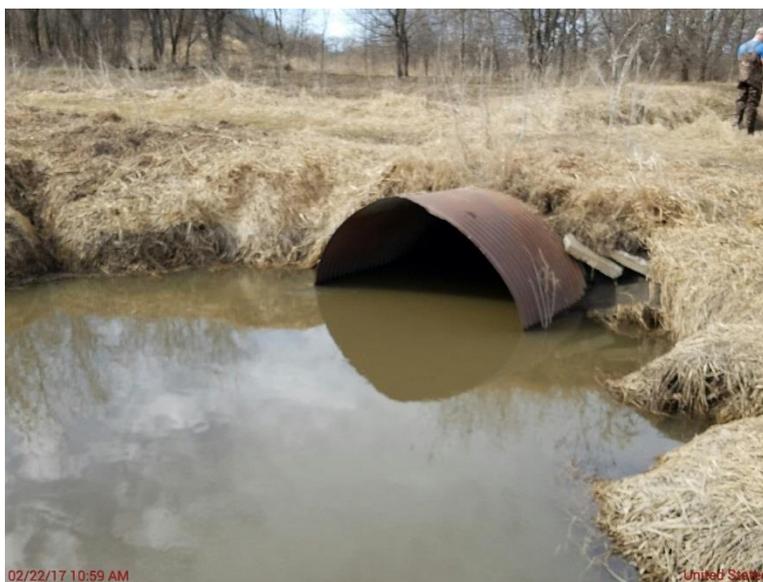
Figure 17: Rusting 96-inch culvert with little cover in NE 1/4 NE 1/4 of Section 28 in Lexington Township on Mainline (Crossing #7)

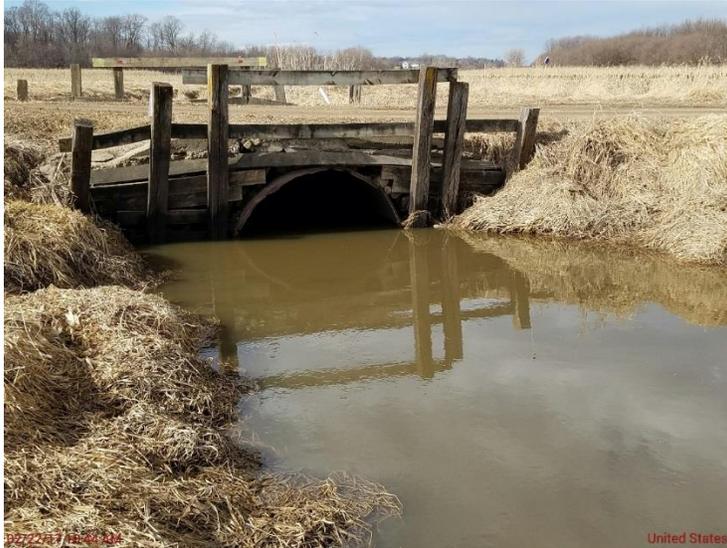
Figure 18: 84-inch Culvert/bridge in the NW $\frac{1}{4}$ NW $\frac{1}{4}$ of Section 27 of Lexington Township on Mainline (Crossing #8)

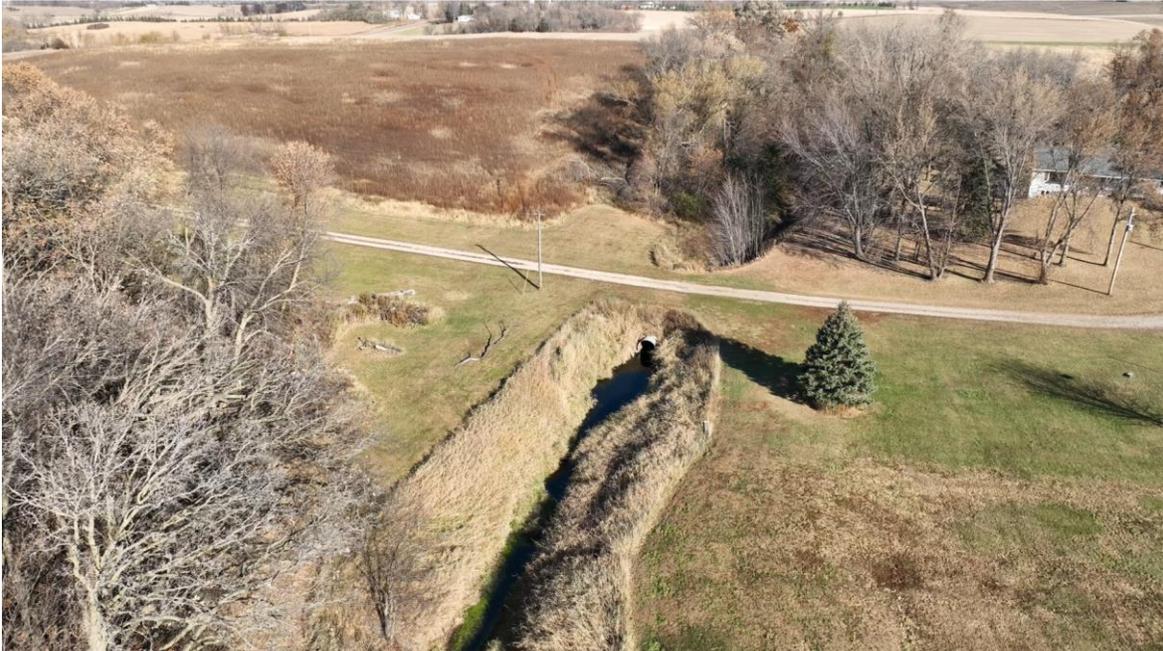
Figure 24: Downstream End of Culvert Crossing #14

Proposed Repair: Side slope repairs and armoring culvert with riprap

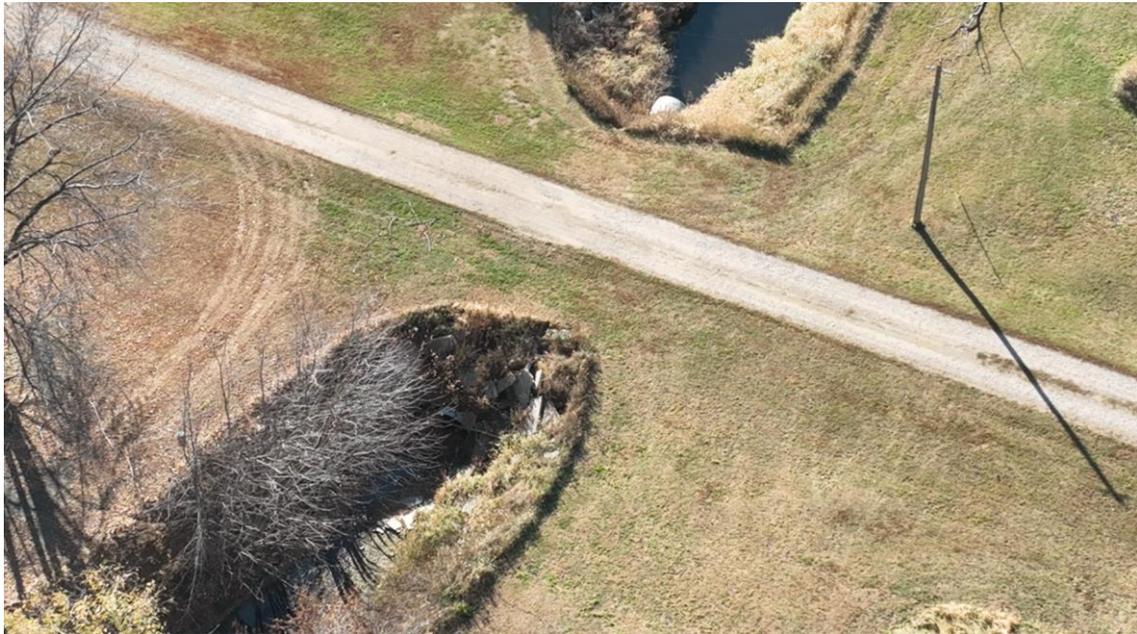
Figure 25: Upstream End of Culvert Crossing #14

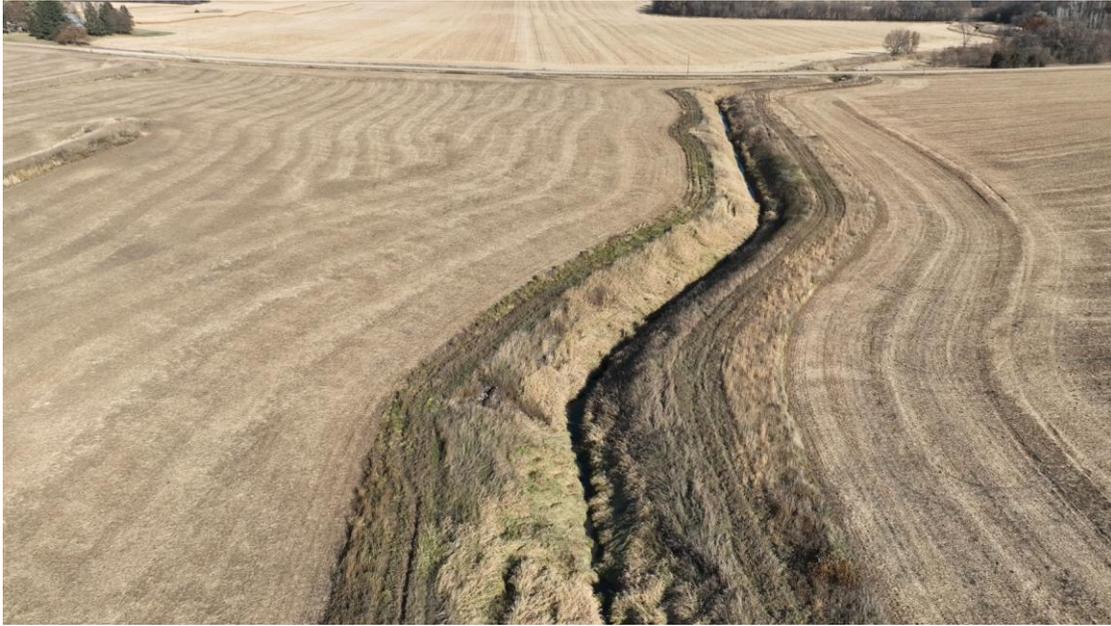
Figure 26: Bank Repairs and ASIs

Proposed Repair: Side slope repairs and alternative side inlets

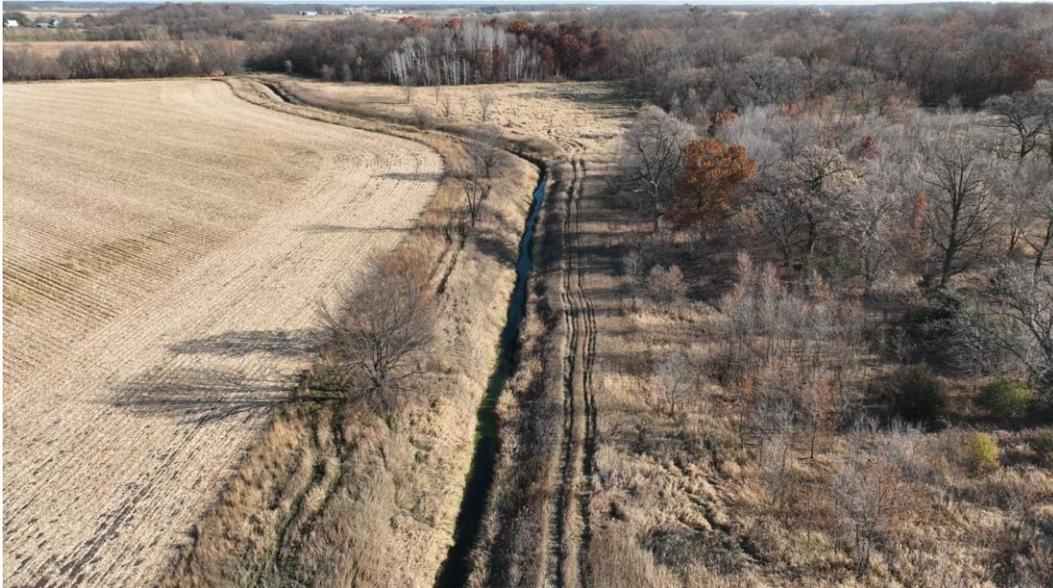
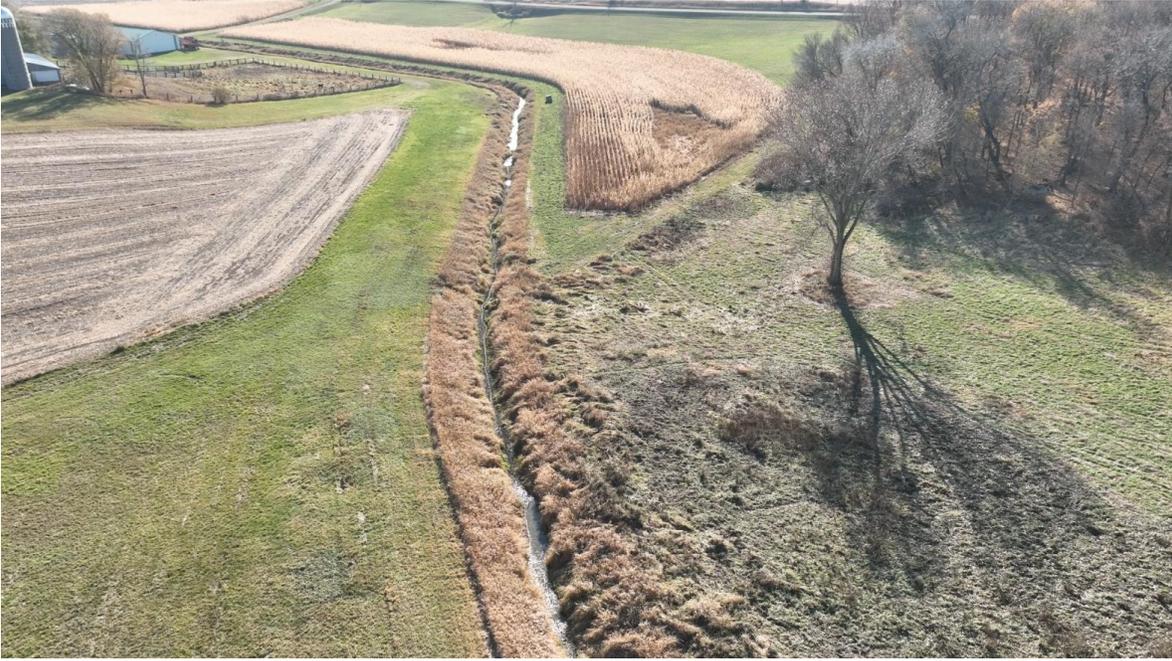
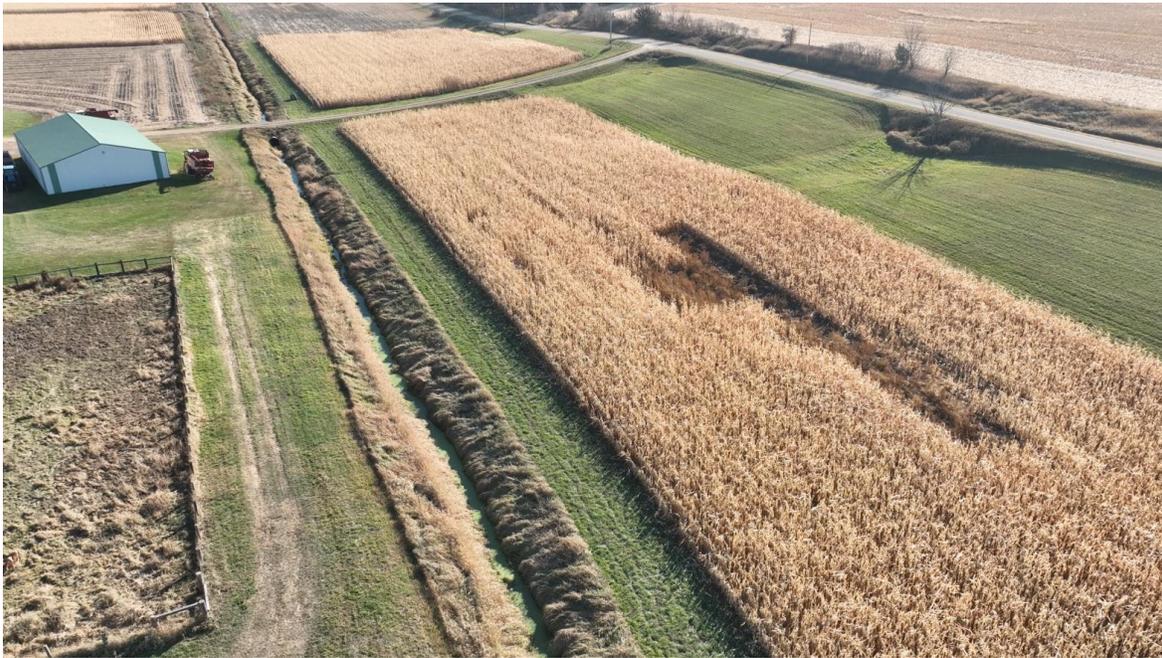
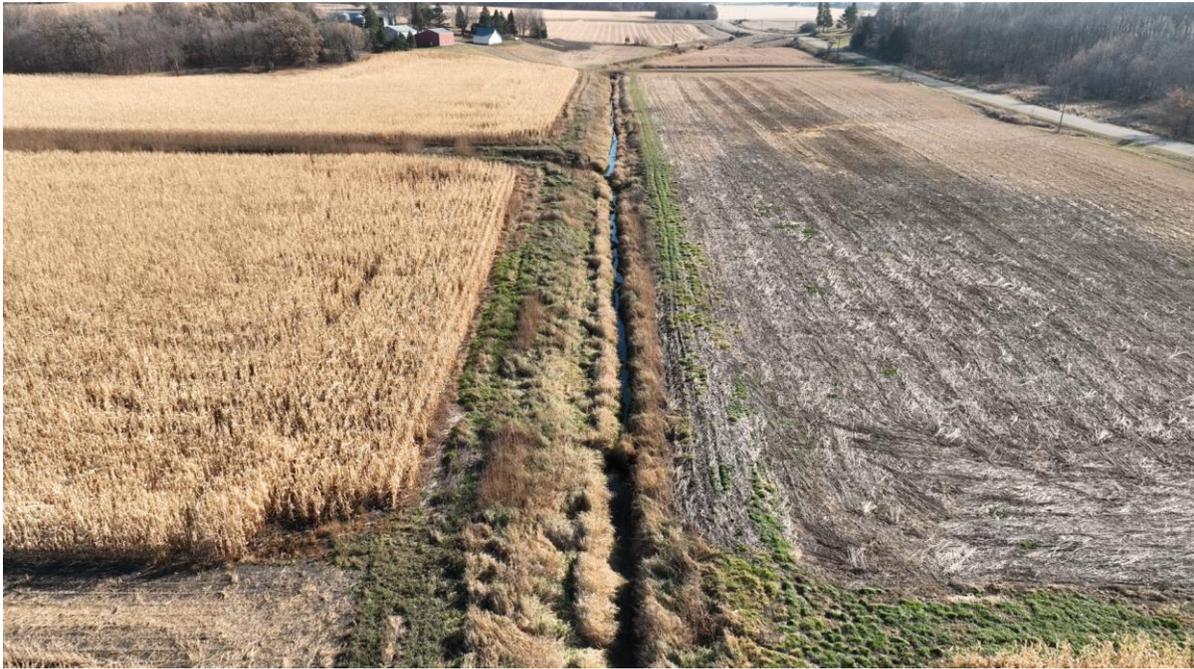
Figure 27: Mainline Open Ditch Cleaning Location

Figure 30: Mainline Open Ditch Cleaning Location

Figure 31: Mainline Open Ditch Cleaning Location

Figure 32: Mainline Open Ditch Cleaning Location

Proposed Repair: Open ditch cleaning, tree removal, and side slope repairs

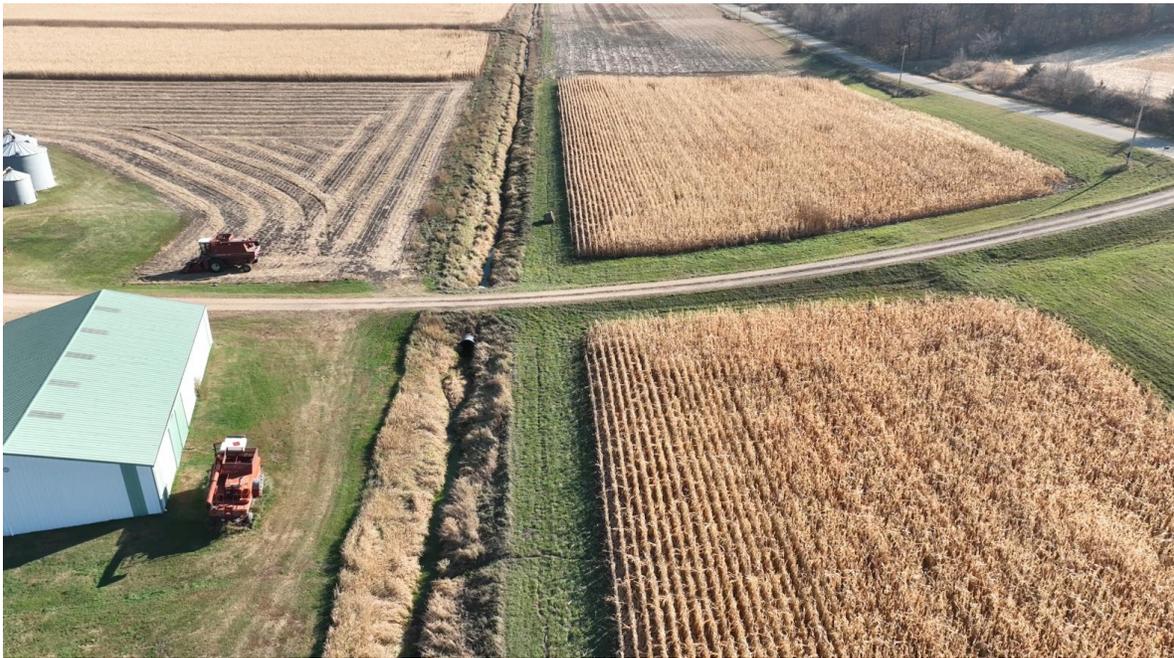
Concern: Driveway culvert in need of replacement

Figure 33: Culvert Crossing #19

Proposed Repair: Remove and replace culvert and armor with riprap

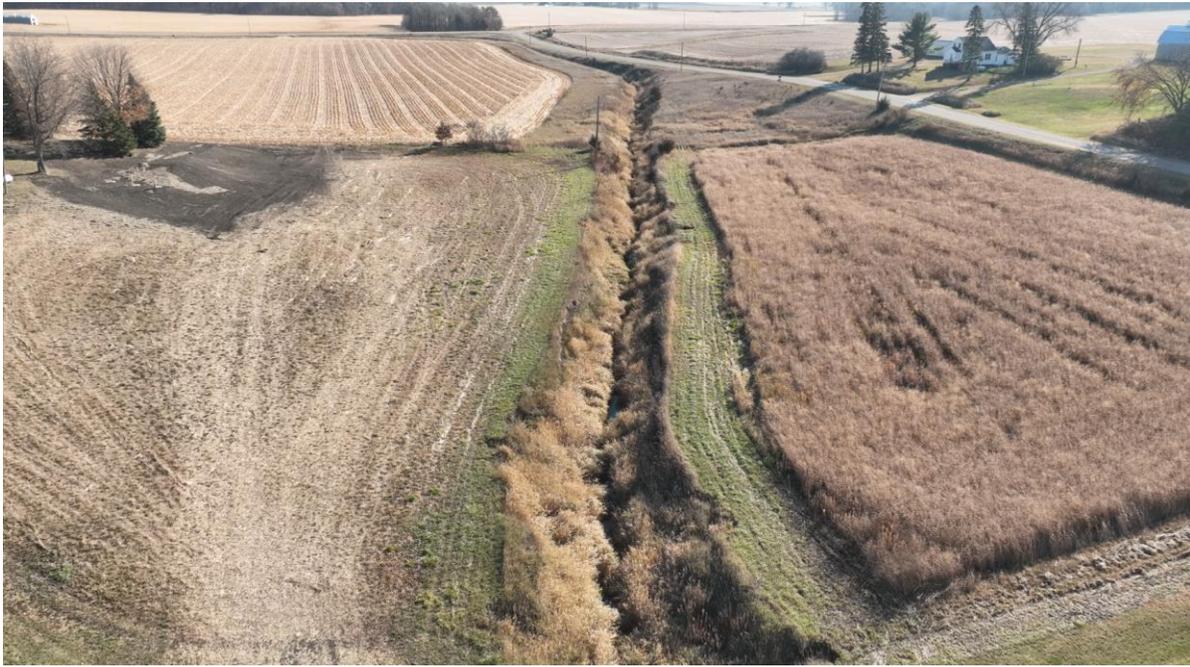
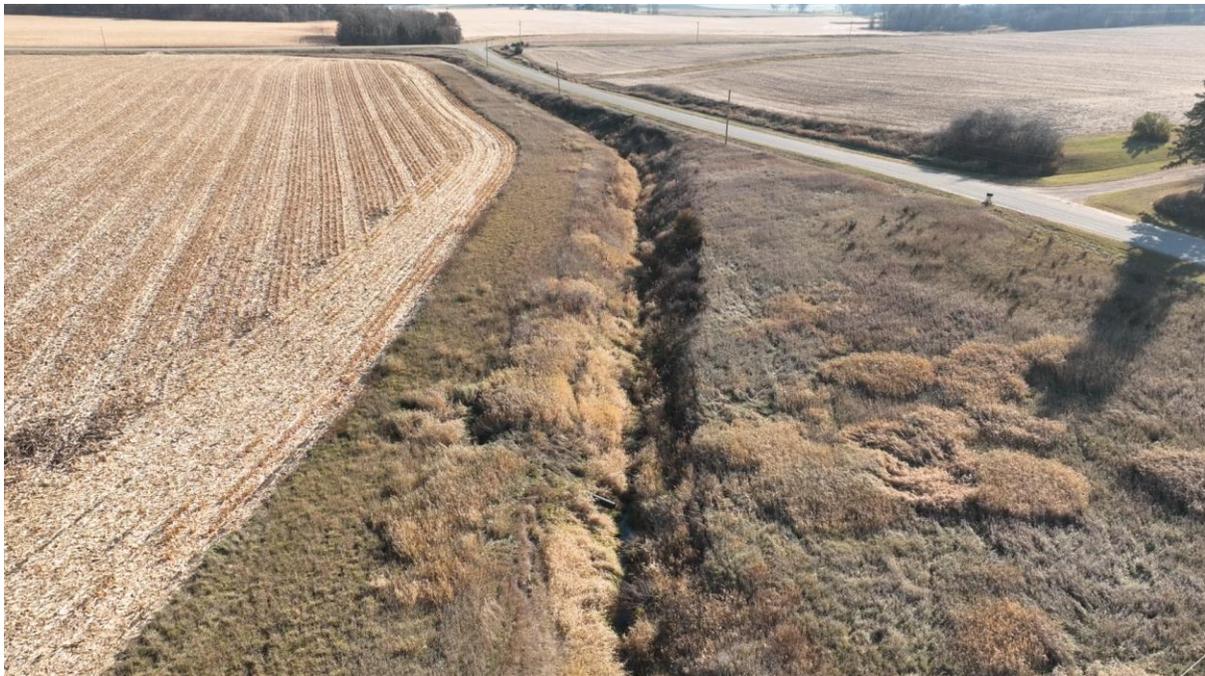
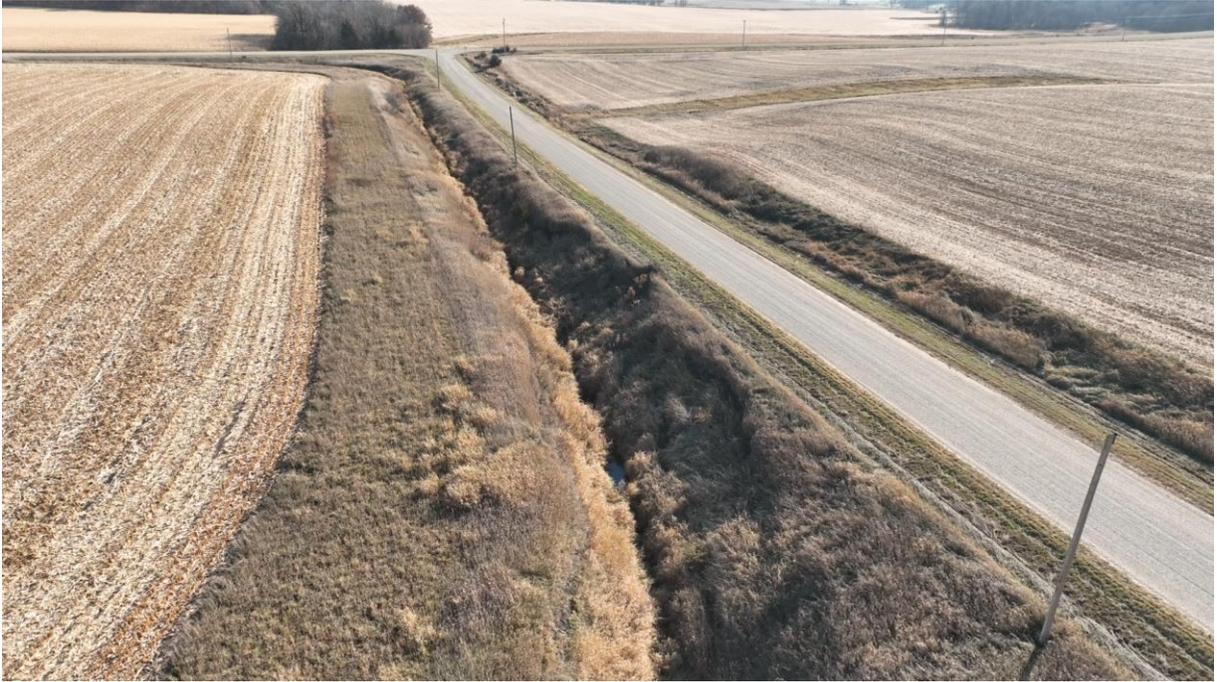
Figure 34: Spur 8 Open Ditch Side Slope Failures

Figure 35: Spur 8 Open Ditch Side Slope Failures

Figure 36: Spur 8 Open Ditch Side Slope Failures Along County Road 125

Proposed Repair: Side slope repairs, side slope armoring, open ditch cleaning, armoring culvert crossing #22.

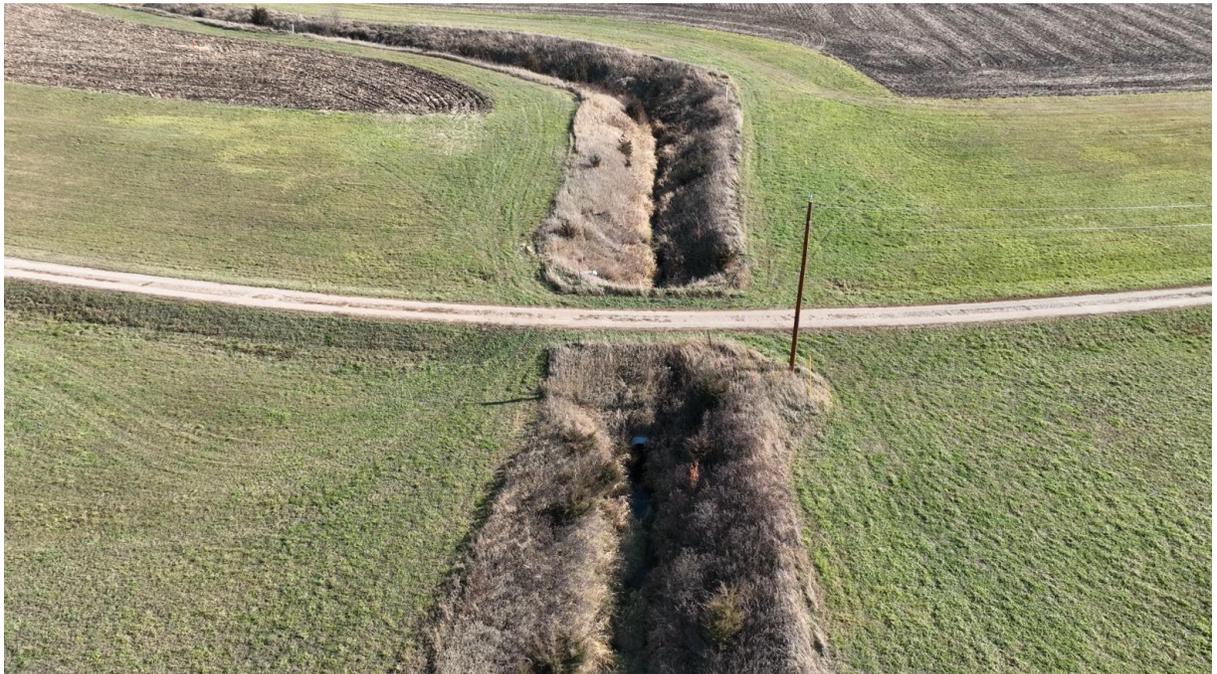
Figure 37: Spur 9 Open Ditch Crossing #31 Driveway Crossing

Proposed Repair: Side slope repairs and armoring culvert with riprap

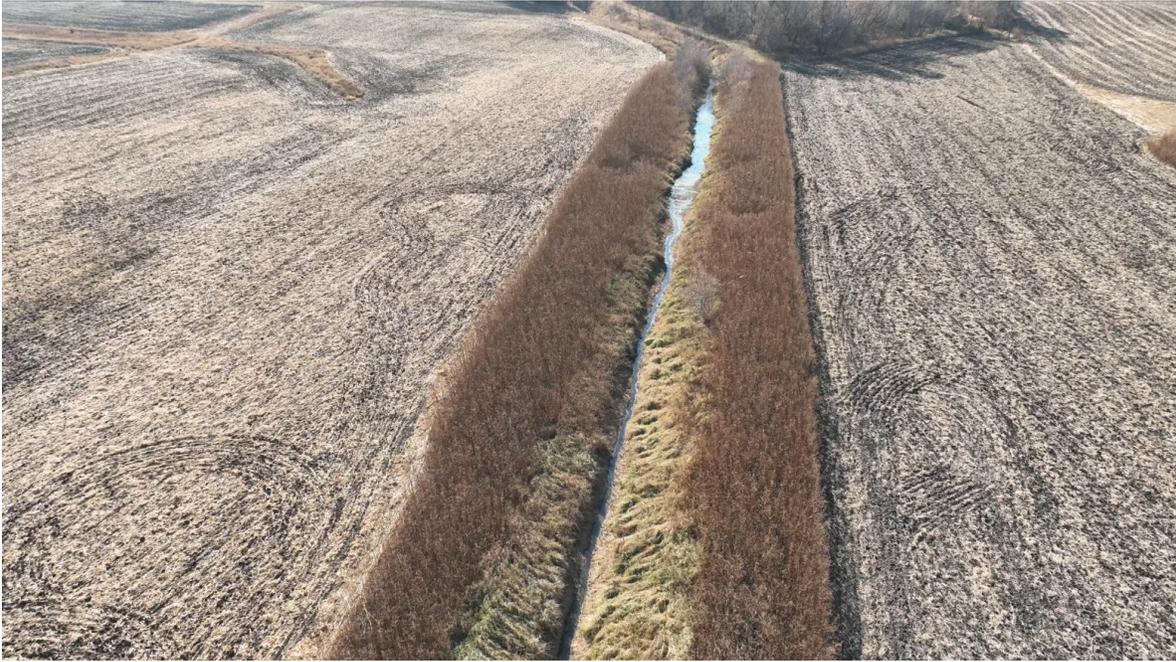
Figure 38: Spur 2 Open Ditch Cleaning

Proposed Repair: Open ditch cleaning and side slope repairs

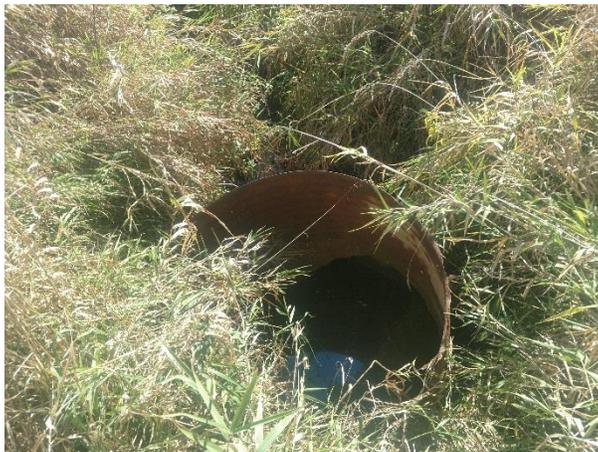
The Mareks Lake outlet structure is currently dilapidated and in need of replacement. The public water basin provides high quality habitat and ability for water storage with the replacement of the outlet structure. Multiple avenues of funding were explored to assist in funding the replacement of the structure. The Le Sueur County SWCD, Drainage Authority, and ISG met with the DNR to discuss the possibility of applying for the DNR – Conservation Partners Legacy (CPL) grant for the replacement of the Mareks Lake structure. There was limited historical data on the structure's installation or ownership. There was also no water quality data or fish or macroinvertebrate monitoring for Mareks Lake. Due to limited public access and limited monitoring data, there is little evidence of its value as a habitat resource and with no public access there is little public recreational value to the basin. Therefore, there was a low likelihood of receiving the grant based on the CPL grant goals. Continued discussions of available funding sources for Mareks Lake took place with the US Fish and Wildlife Service. There was interest in utilizing the basin for local storage by raising the maintained pool area. There was limited interest from landowners adjacent to Mareks Lake due to possible impacts to lands and drainage around the lake.

Figure 39: Existing 48-inch CMP outlet structure for Mareks Lake

As part of the repair, the existing broken outlet structure will be removed and replaced with a 60-inch concrete drop structure with 36-inch outlet pipe. The top of the drop structure will be set approximately one foot below the OHW elevation, 1044.50. Due to erosion, there are large scour holes around the structure. Approximately 25 cubic yards of common borrow and 35 cubic yards of riprap will be used to stabilize and protect the berm from erosion. A public waters permit is needed before work can take place on the Mareks Lake structure replacement.

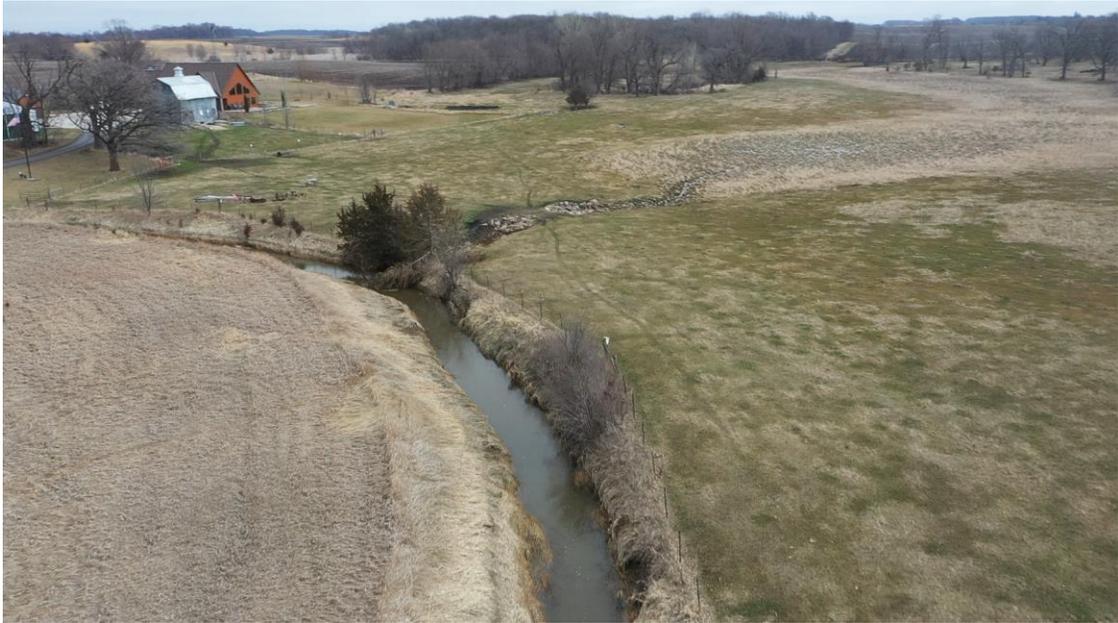
Figure 42: Les Hartwig storage location on Main open ditch at Sta. 232+00

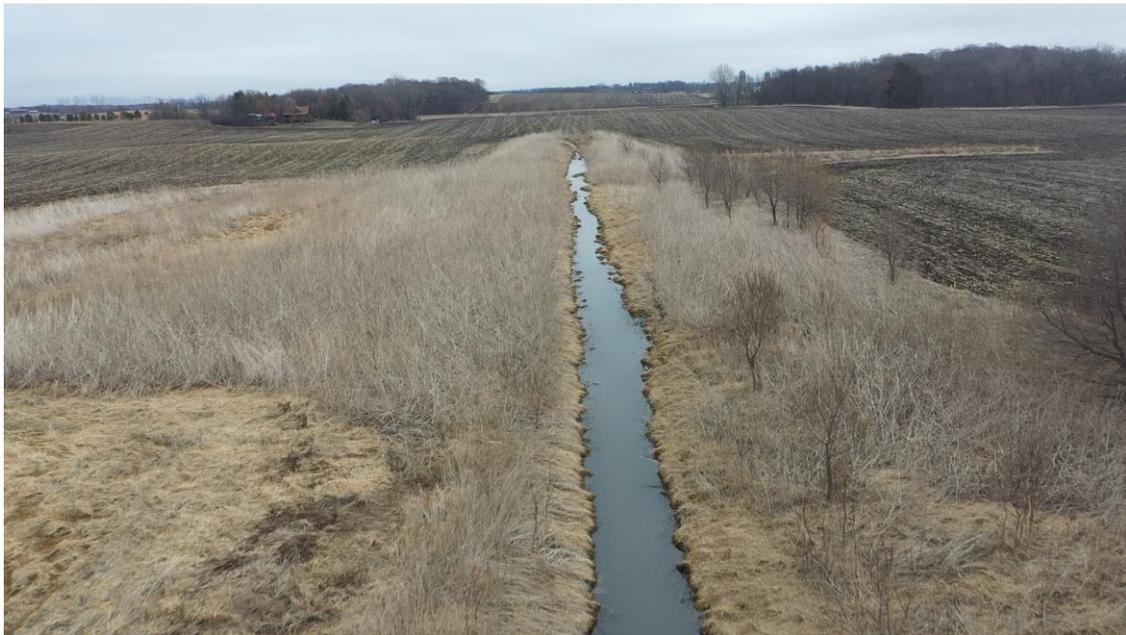
Figure 43: Bromstrom storage location on Spur 9 open ditch at Sta. 185+00

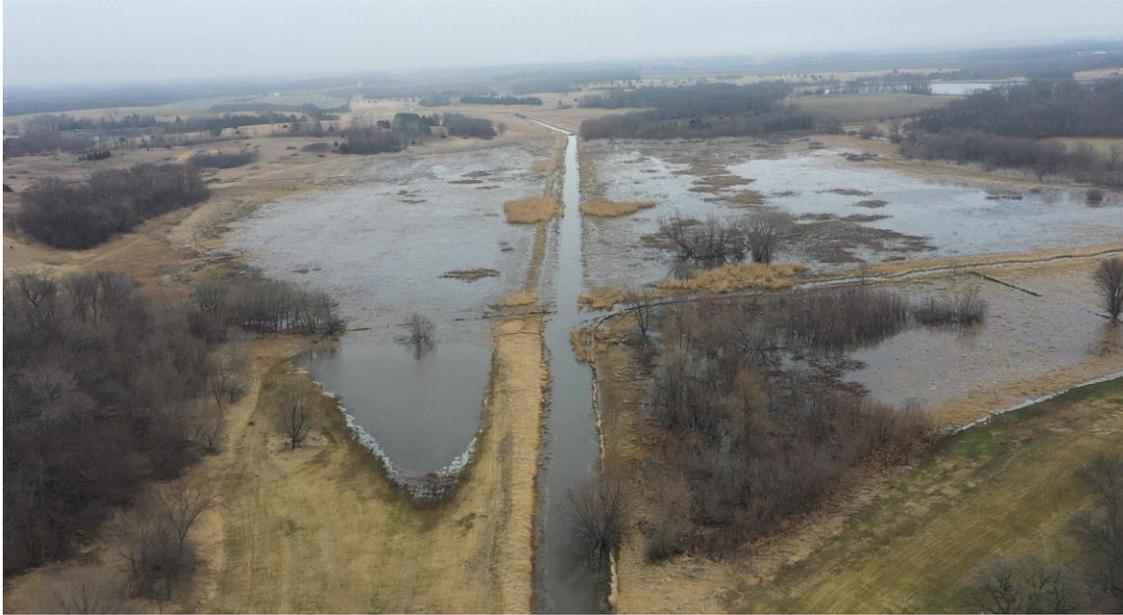
Figure 44: Witter storage location on Mainline open ditch at Sta. 115+00
