# Feasibility Report

# County Ditch No. 51

Le Sueur County, Minnesota

Date: August 21<sup>st</sup>, 2023

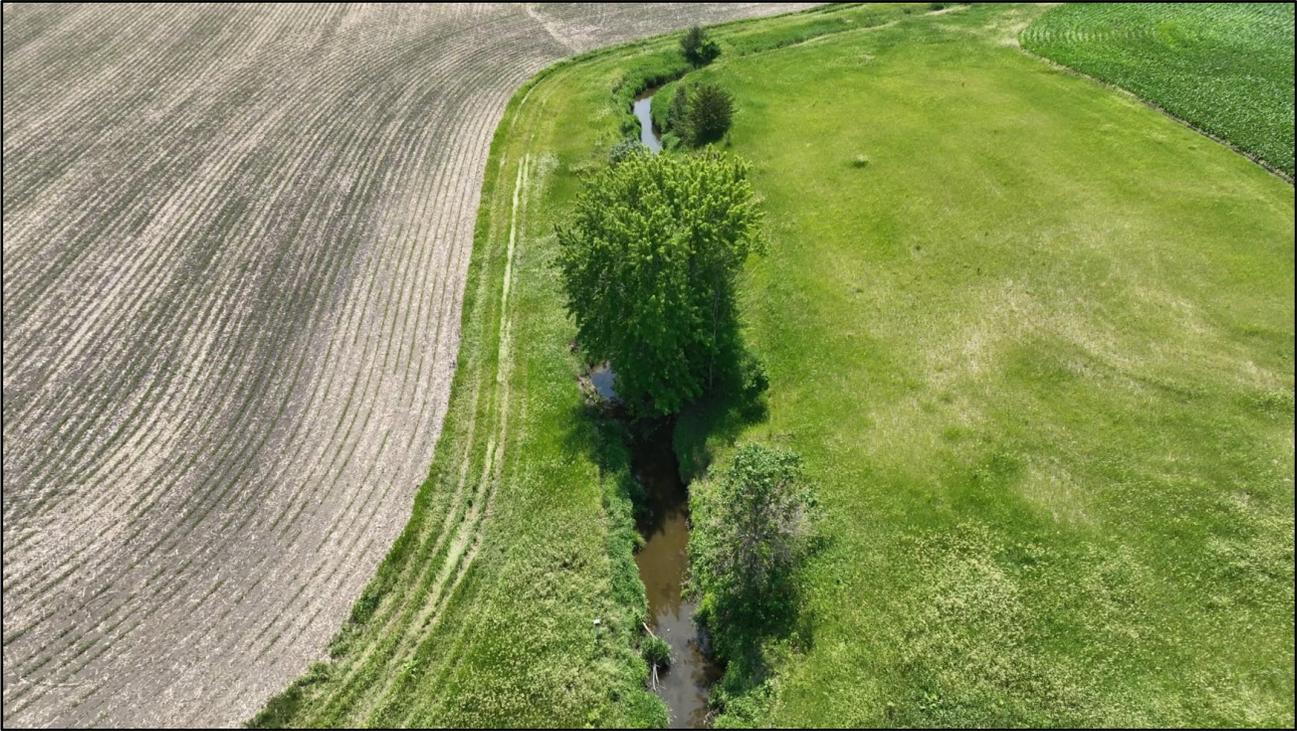
*Figure 1: Tree in ditch near the outlet*

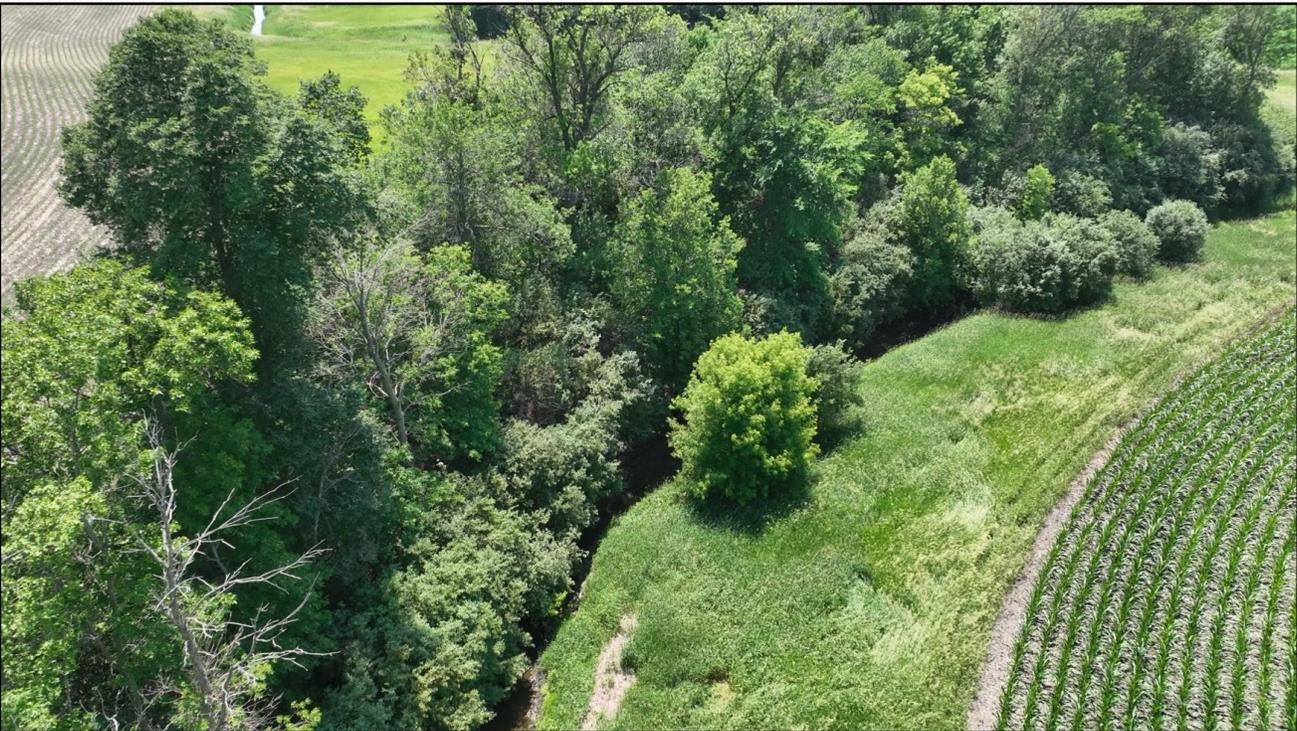
*Figure 2: Dense Trees near the outlet*

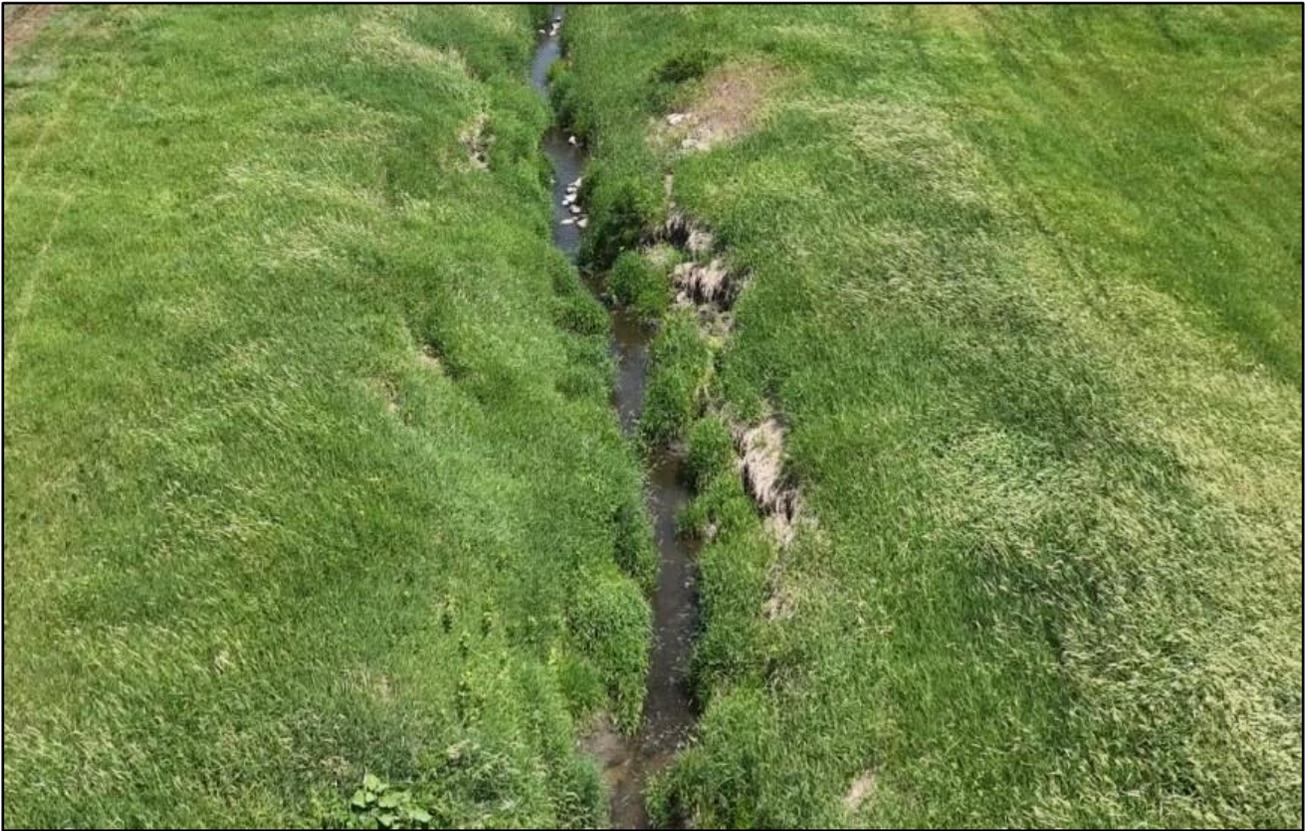
*Figure 3: Sloughing along mainline open ditch*

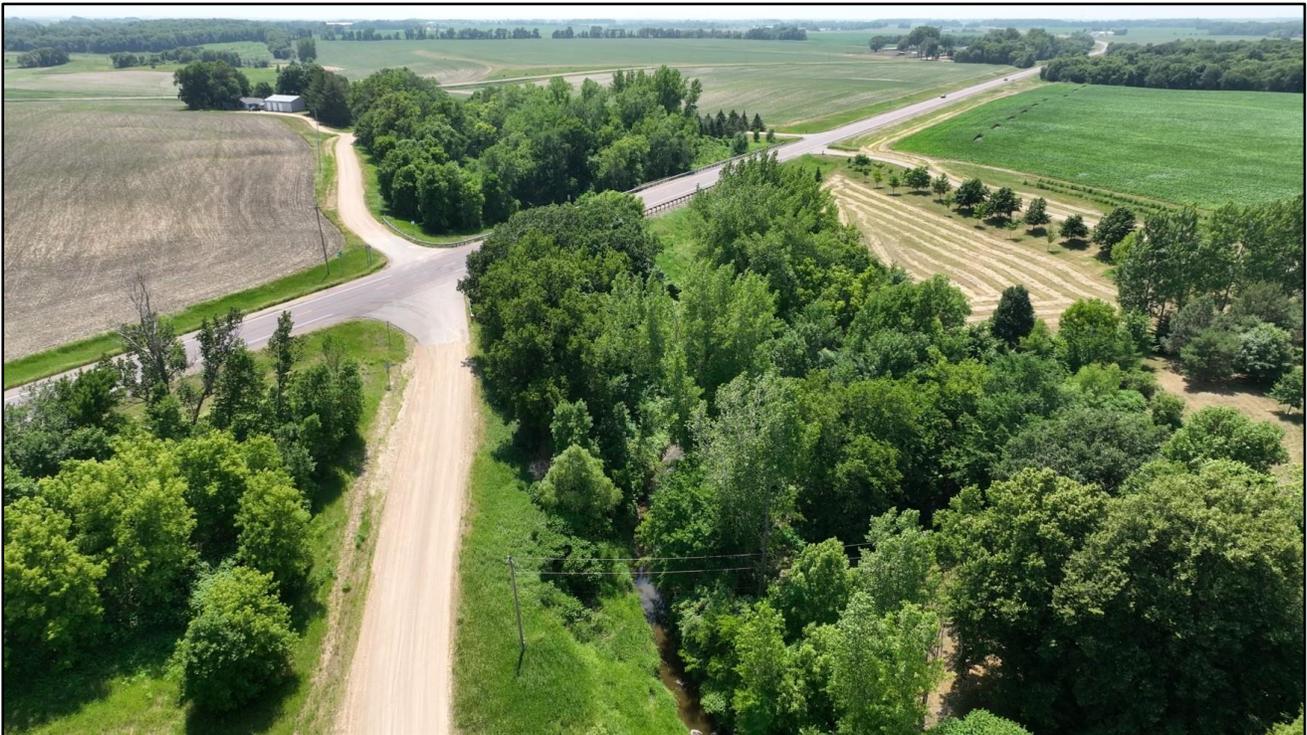
*Figure 4: Dense Trees near TH 99 crossing*

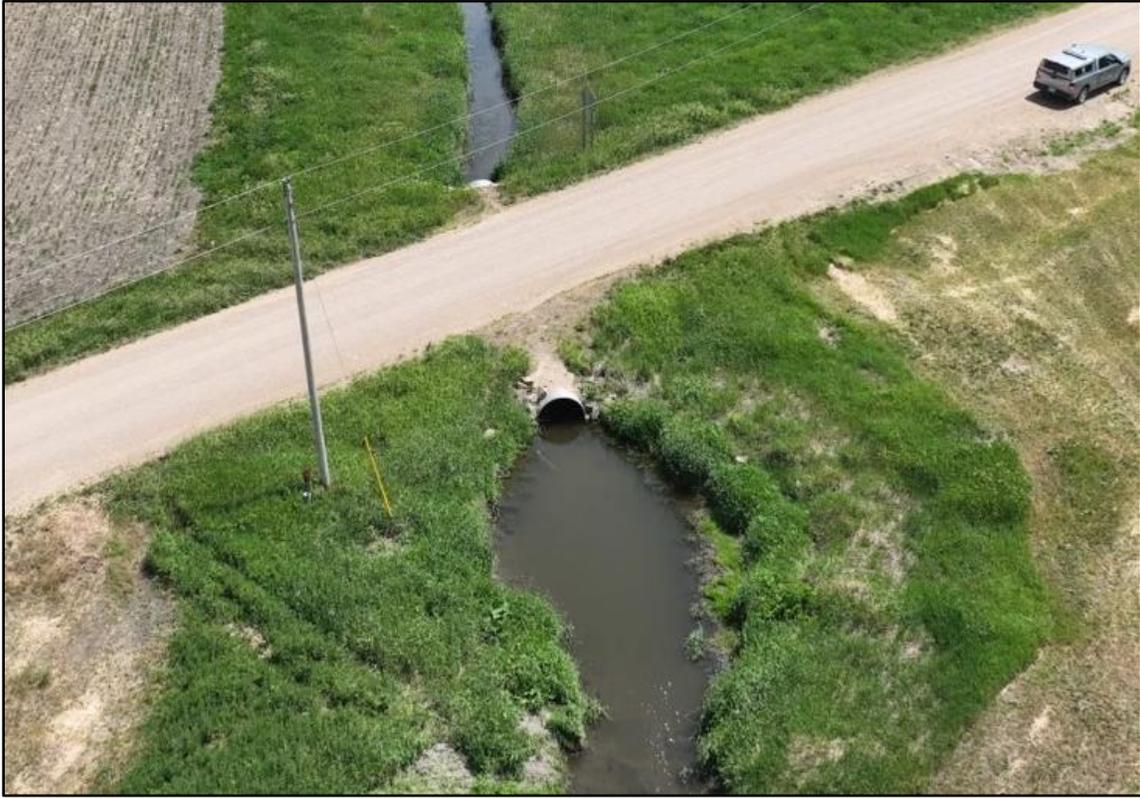
*Figure 5: Scour at 400<sup>th</sup> Street crossing*

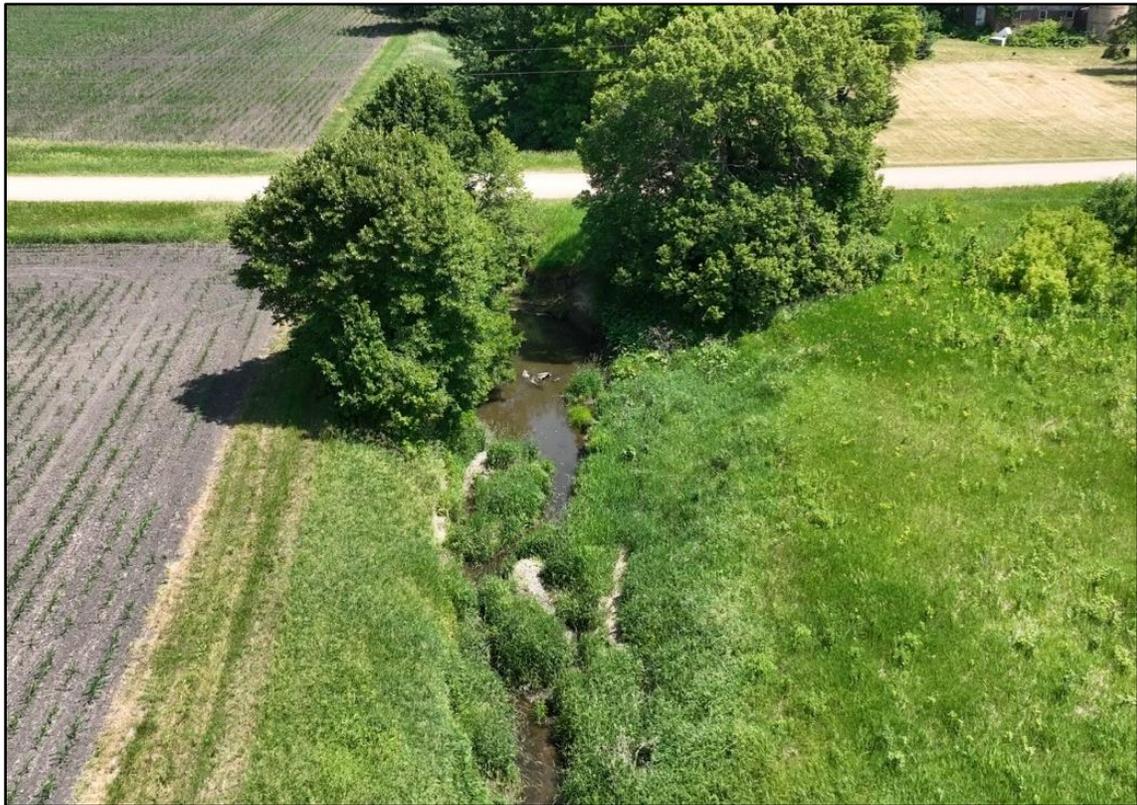
*Figure 6: Sediment accumulation and vegetation growth at 245<sup>th</sup> Avenue crossing*

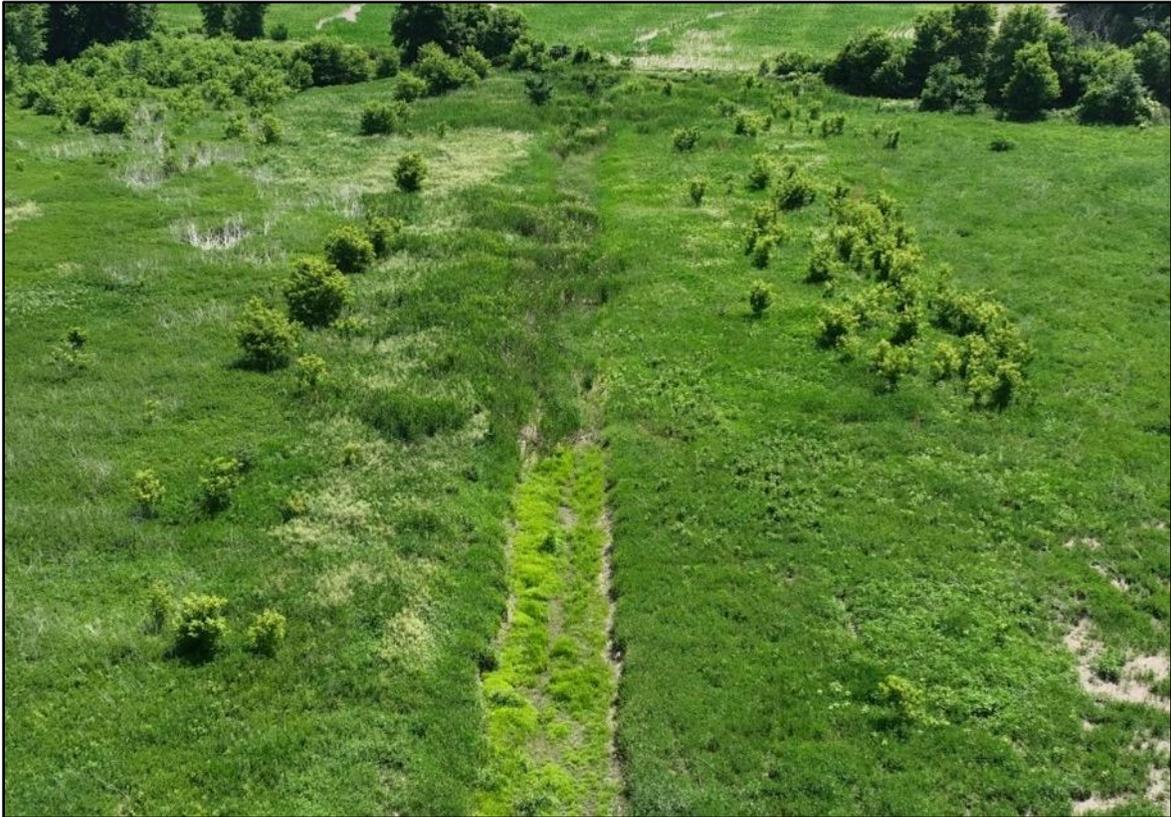
*Figure 7: End of Spur 4*

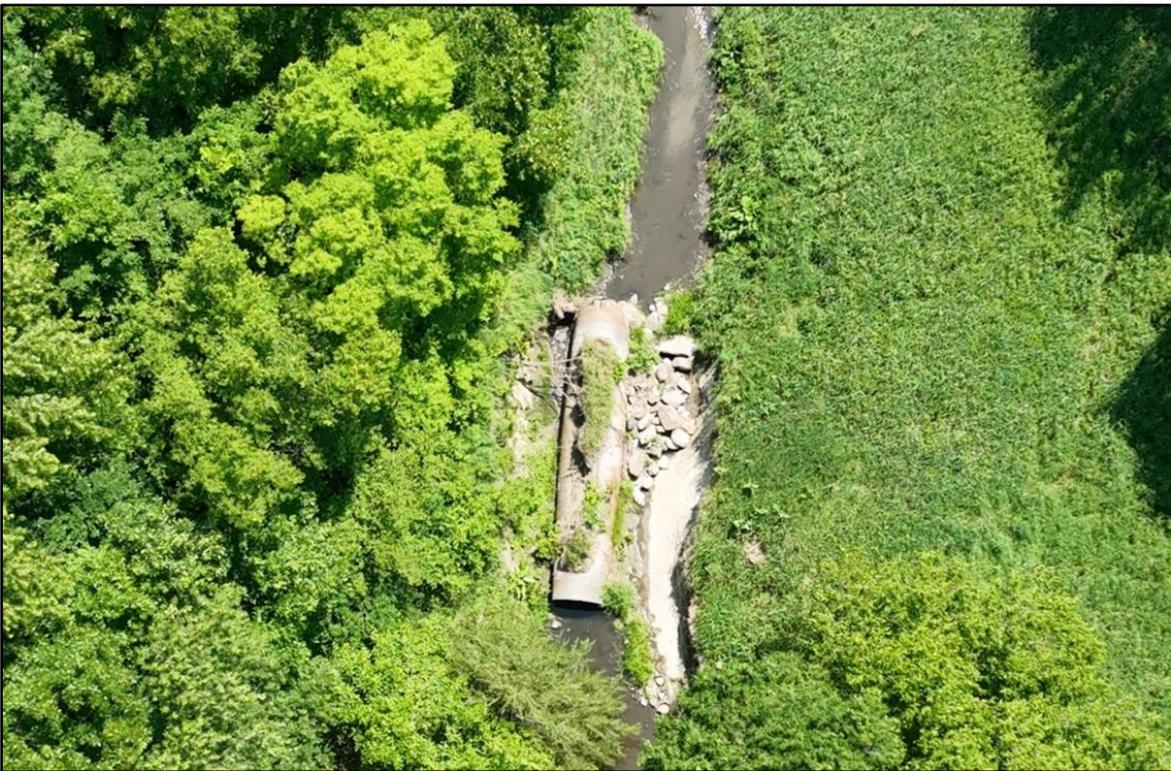
*Figure 8: Failing field crossing culvert on the Mainline east of 245th Avenue (Crossing #10)*

**AREAS OF CONCERN REPAIR OPTION**  
**Culvert Crossing #10 (Field Crossing - Main)**

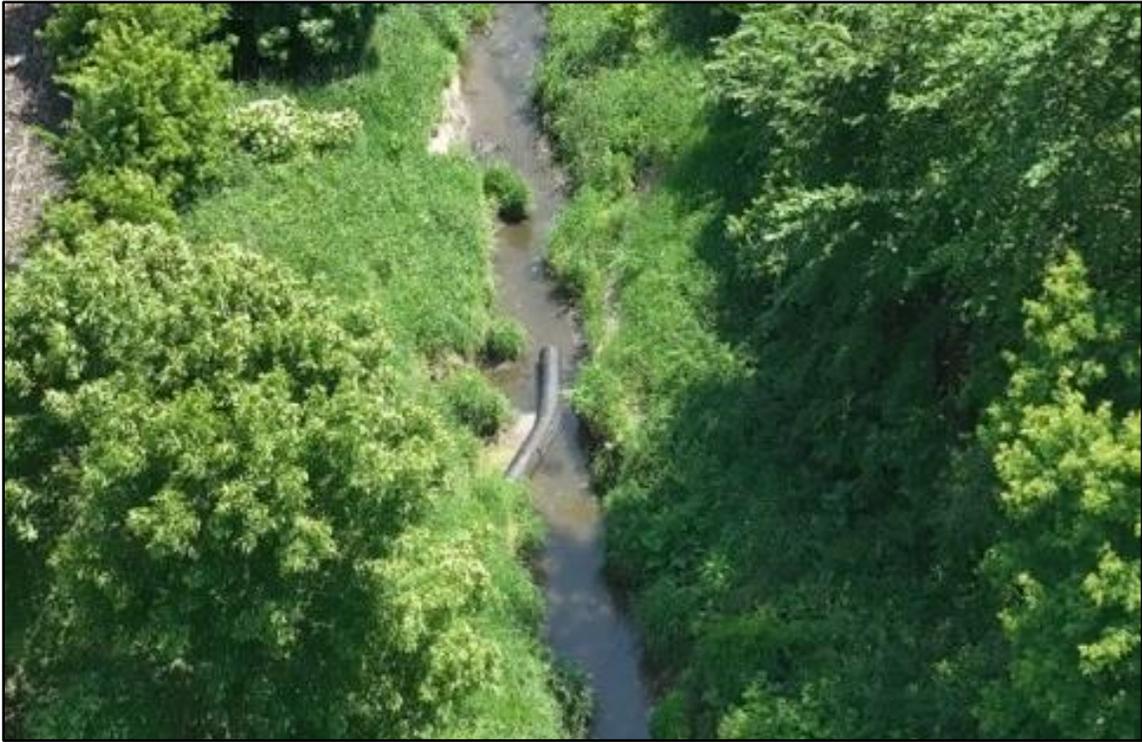
*Figure 9: Private tile facing upstream on the Mainline east of 245<sup>th</sup> Avenue*

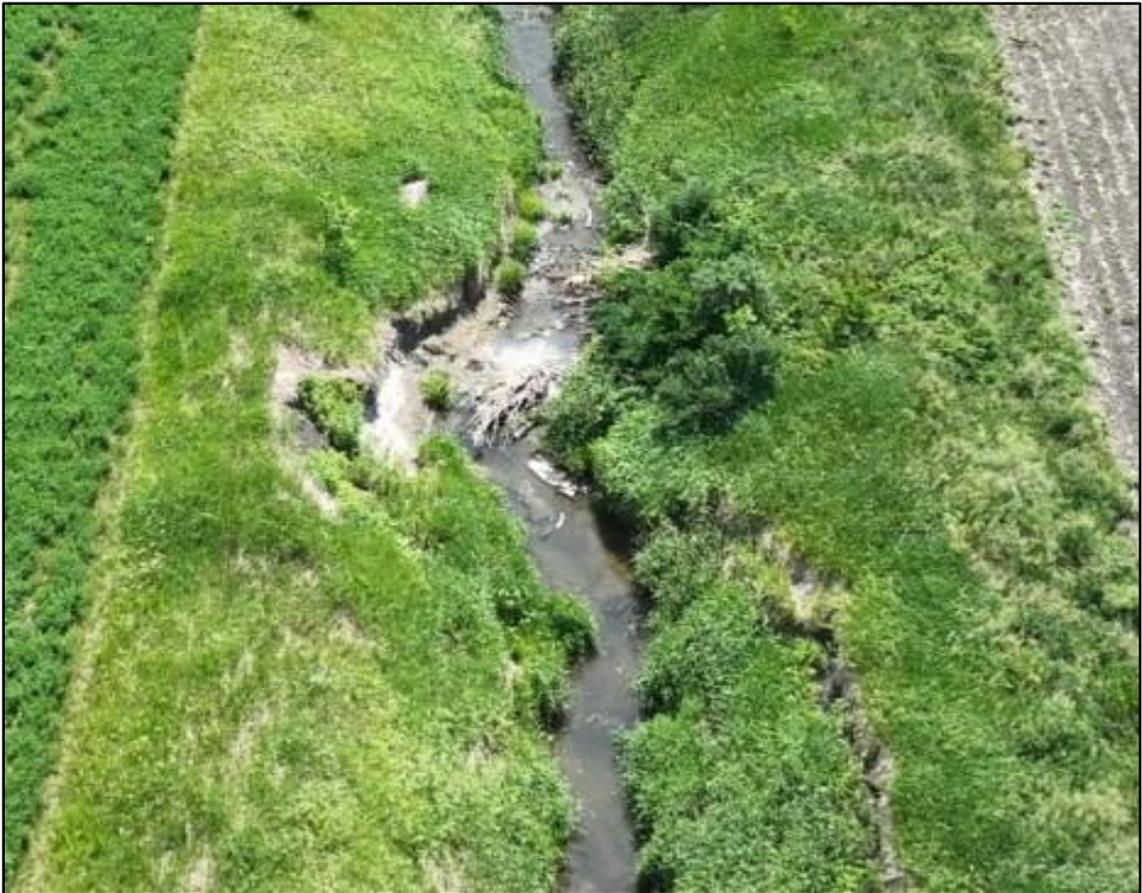
*Figure 10: Sloughing west of South Maple Avenue along Mainline open ditch*

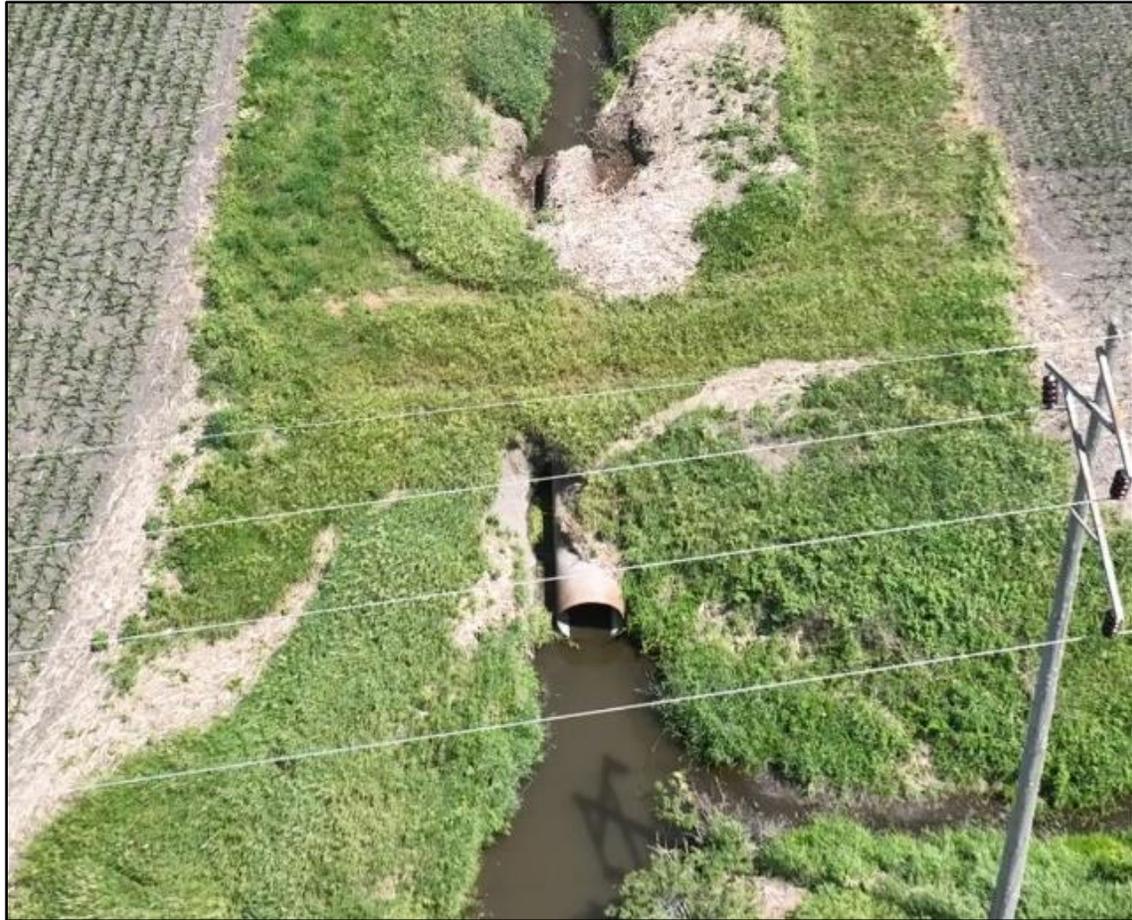
Figure 11: Failing CMP field crossing culvert east of South Maple Avenue along Mainline open ditch (Crossing #13)

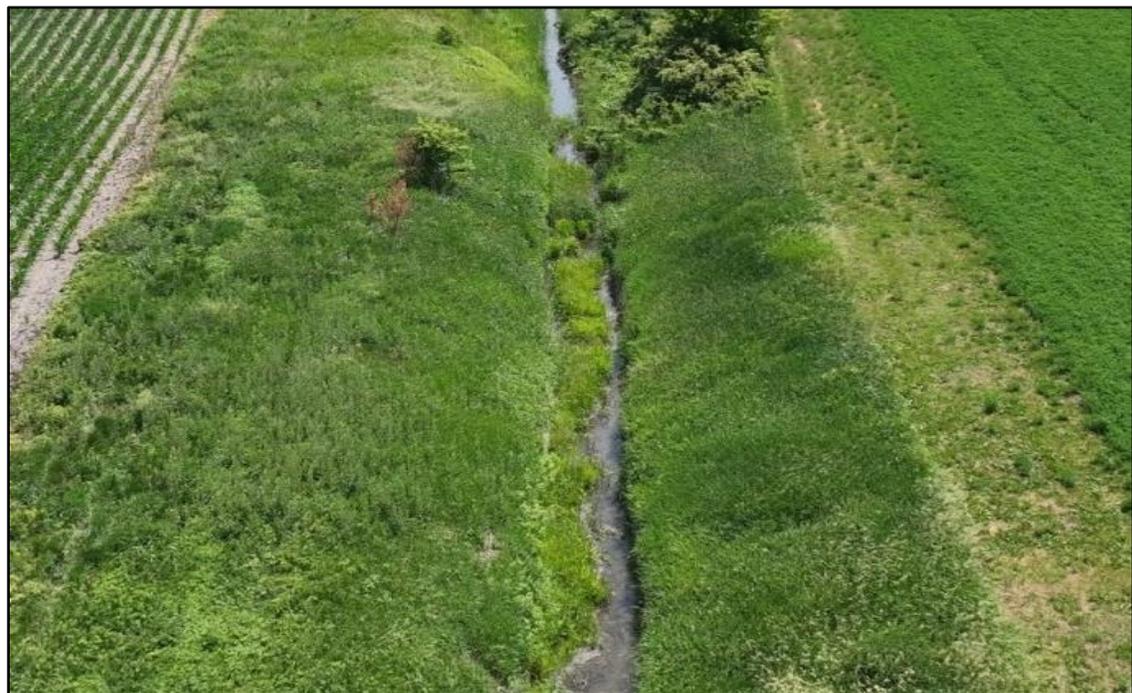
Figure 12: Sediment accumulation and vegetation growth in Spur 2 open ditch north of 237<sup>th</sup> Avenue

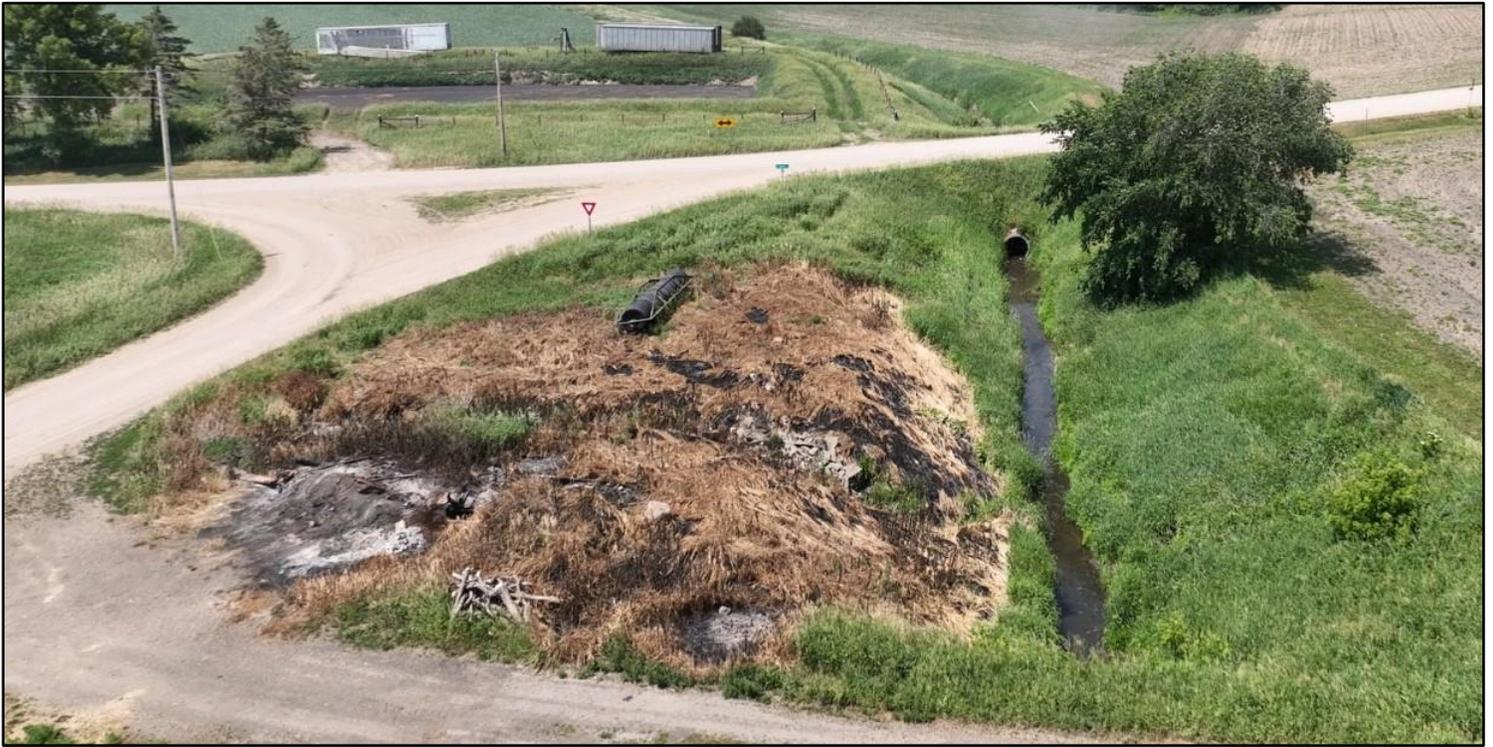
Figure 13: Burn pile debris in ditch and buffer on Mainline open ditch south of South Maple Avenue

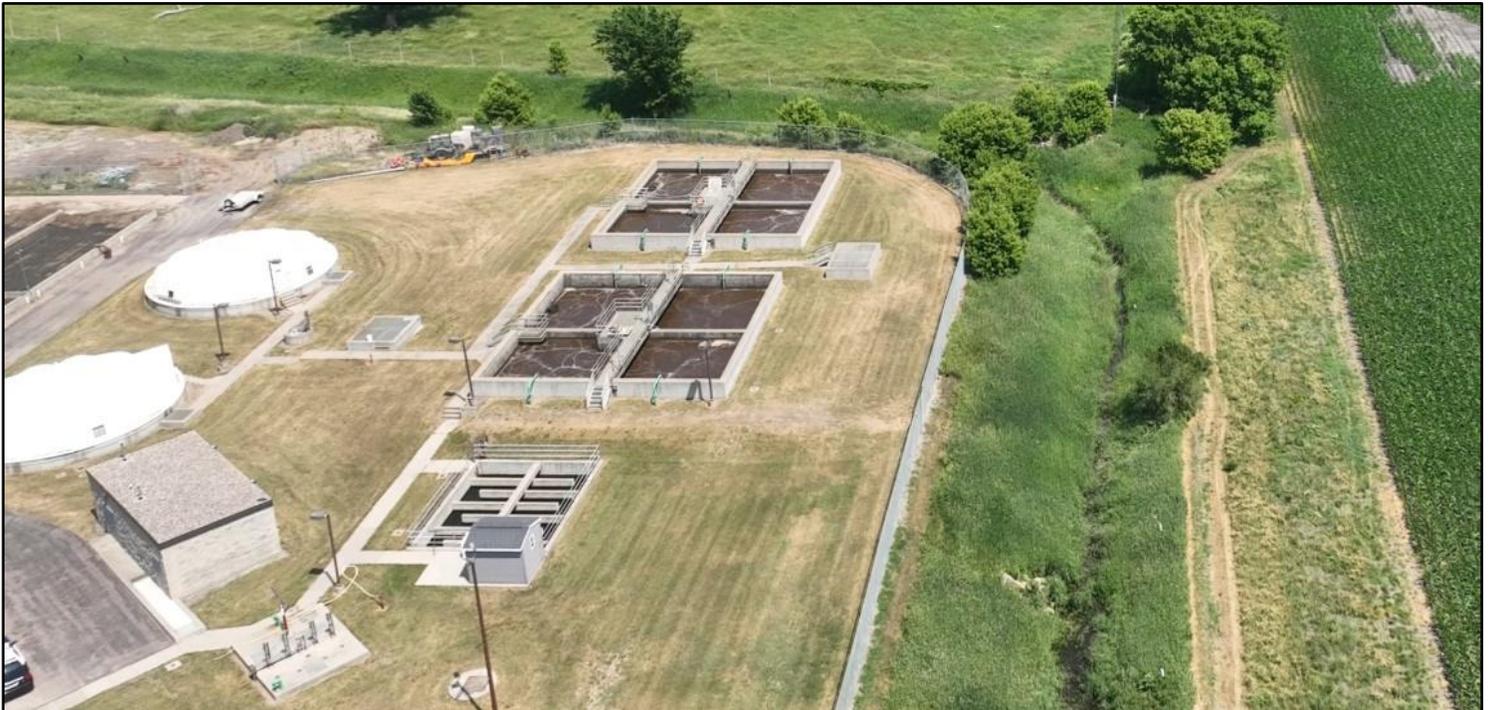
Figure 14: City of Le Center water treatment outlet into CD 51 Mainline open ditch
