EURASIAN WATERMILFOIL INFESTATION REPORT: Sunfish Lake, Le Sueur County

MnDNR – Division of Ecological and Water Resources - Invasive Species Program

Type of report: Eurasian watermilfoil – new infestation

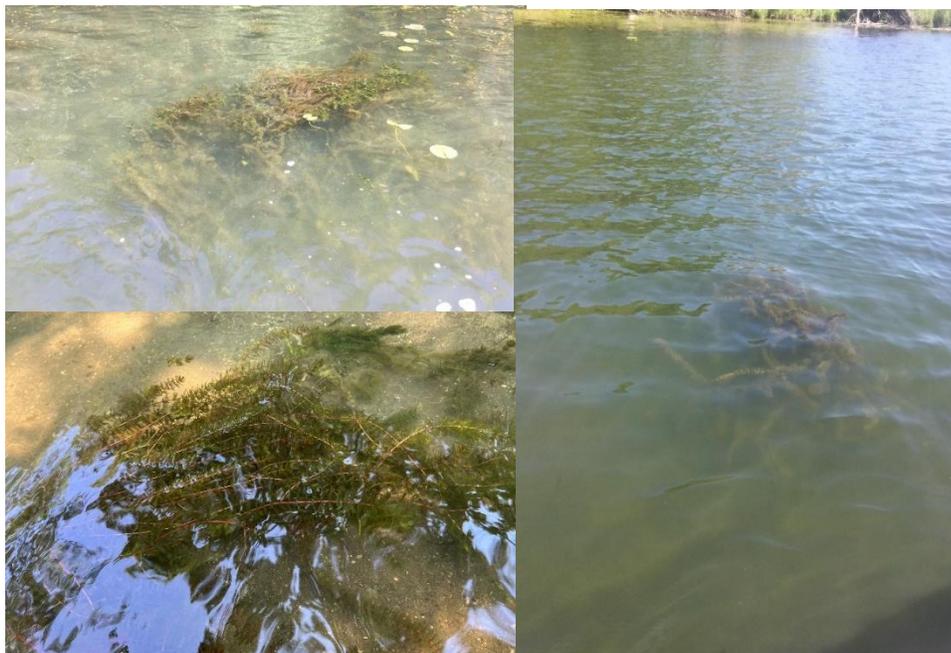
Photos 1-3: Eurasian watermilfoil found near the initial sighting location on Sunfish Lake. It was most often observed in small patches as shown.

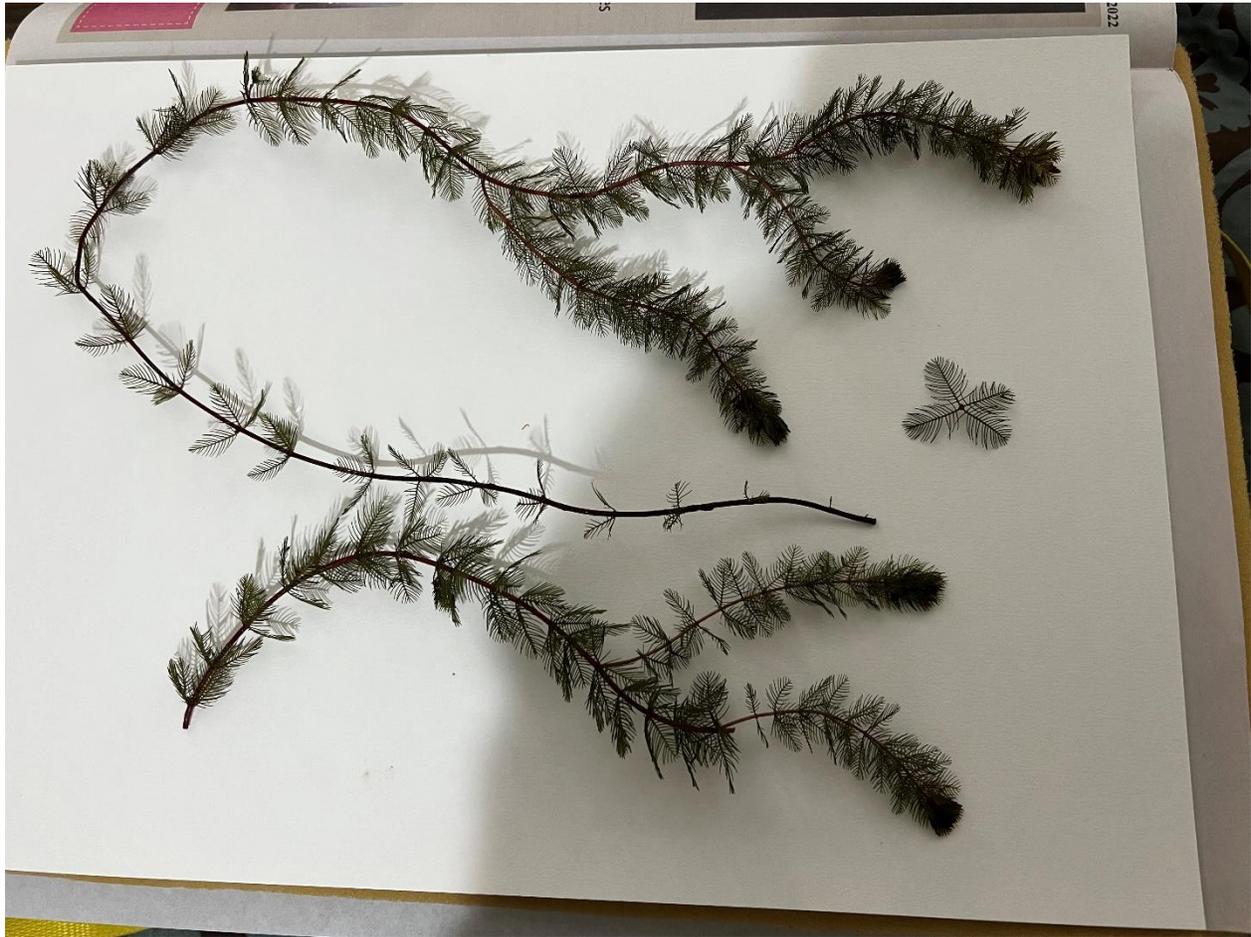
Photo 4: Eurasian watermilfoil pulled from Sunfish Lake by Courtney Millaway on July 27, 2022. Leaflet pairs are >13, consistent with traits of Eurasian watermilfoil.

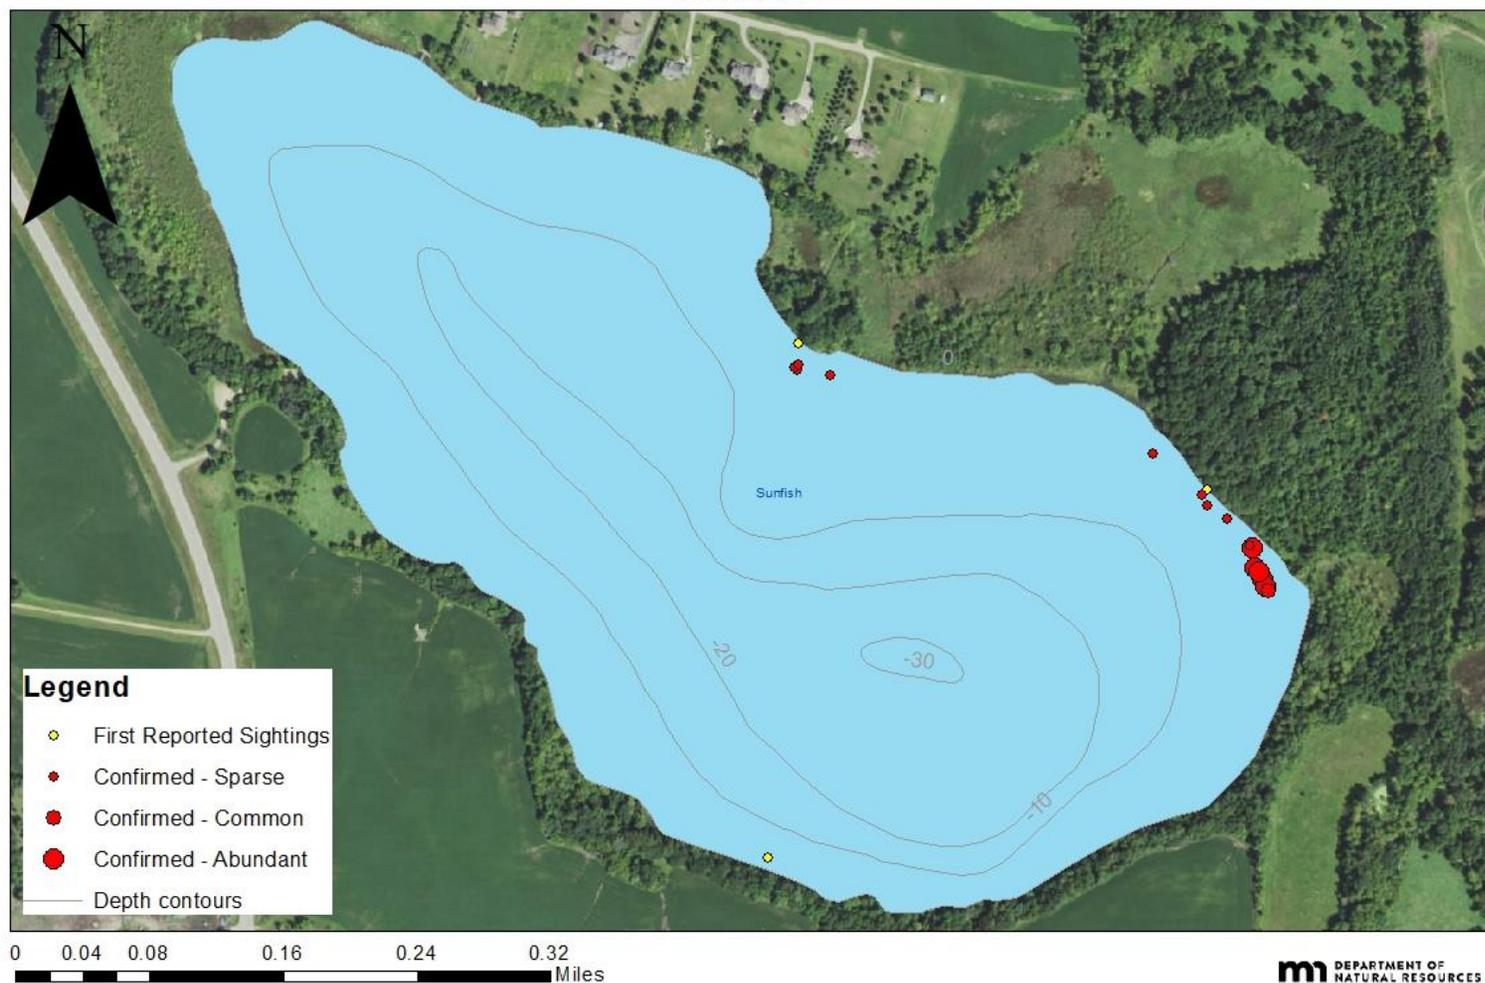
Sunfish Lake
Eurasian Watermilfoil New Infestation
8/9/2022

On July 27, 2022, a DNR aquatic botanist reported suspected Eurasian watermilfoil at three different locations on Sunfish Lake, located on the eastern half of the lake's shore (Figure 1). DNR Invasive Species staff followed up on the report on August 9, 2022 and confirmed Eurasian watermilfoil was present (Photos 1-4 below). The Eurasian watermilfoil observed was often growing in sparse patches mixed with native vegetation, but one small area of dense growth and surface matting was noted (~1,000 sq feet) (Figure 1).

Figure 1: Locations of confirmed Eurasian watermilfoil presence. The yellow dots mark the location for the initial sightings (7/27/2022) and the red dots represent Eurasian watermilfoil found on August 9, 2022. The red dots vary in density from sparse to abundant.

Sunfish Lake was not previously on the Designated Infested Waters list for any AIS, it will now be added as infested with Eurasian watermilfoil. The new occurrence is reported in EDDMapS under Record ID [10643077](#).
