Repair Report

County Ditch No. 23

Le Sueur County, Minnesota

ISG Project No.: 17-20141

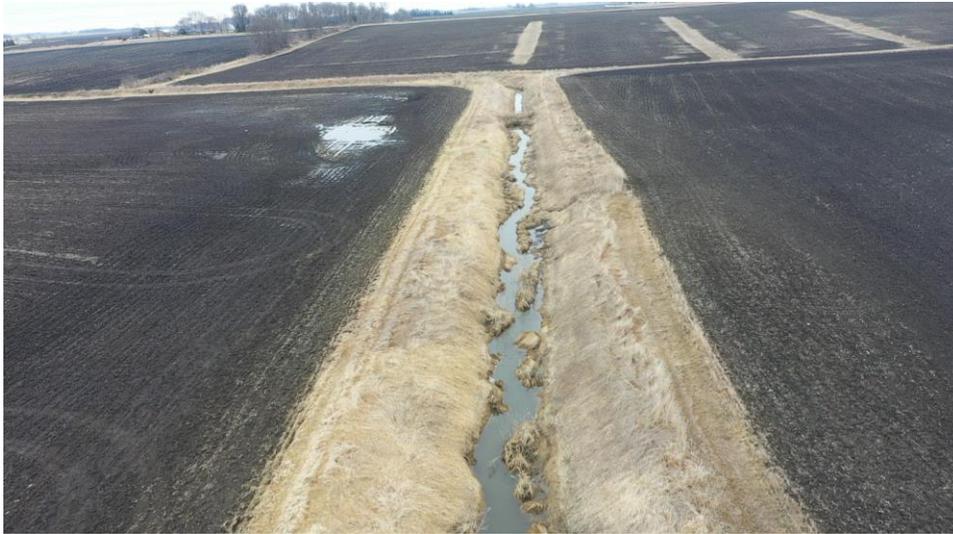
Figure 3: Sediment and vegetation growth in center of Spur 9 open ditch at Sta. 75+00

For ditch systems like CD 23, cleaning is recommended every 8 to 10 years. The topographic survey revealed that a majority of the ditch has accumulated sediment in the channel bottom above the ACSIC grade. The accumulated sediment has led to vegetation growth. It has also caused the flow channel to meander causing slope erosion.

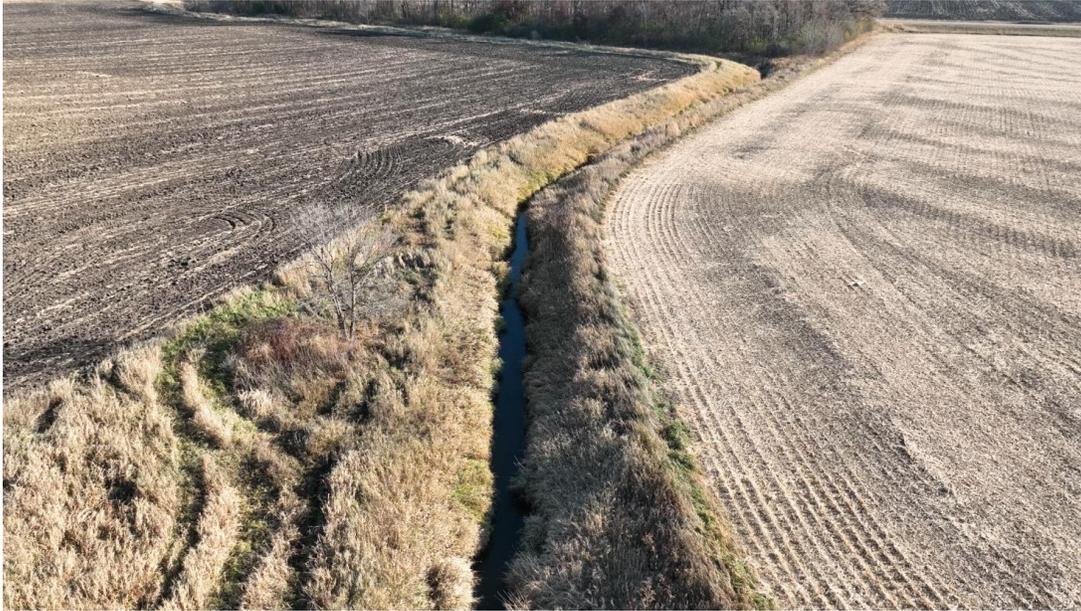
Figure 4: Limited buffers on the Mainline open ditch

Chapter 103E requires the placement of 16.5-foot (1-rod) buffers on all ditches when viewers are appointed. The Minnesota Buffer Law (103F.48) states that there must be a 50-foot buffer along lakes, rivers, and streams and a 16.5-foot (1-rod) buffer on public ditches. A redetermination of benefits was recently completed in which acquisition of the 16.5-foot buffer area is included. A majority of the buffers are established along the CD 23 open ditches. However, there are a few locations where buffers have not been installed or established. During the repair, establishment of the buffer's may be included in the project to accelerate the rate of compliance with the Buffer Law. Buffer areas that are disturbed from construction will be seeded after final grading of the spoils on top of the ditch bank.

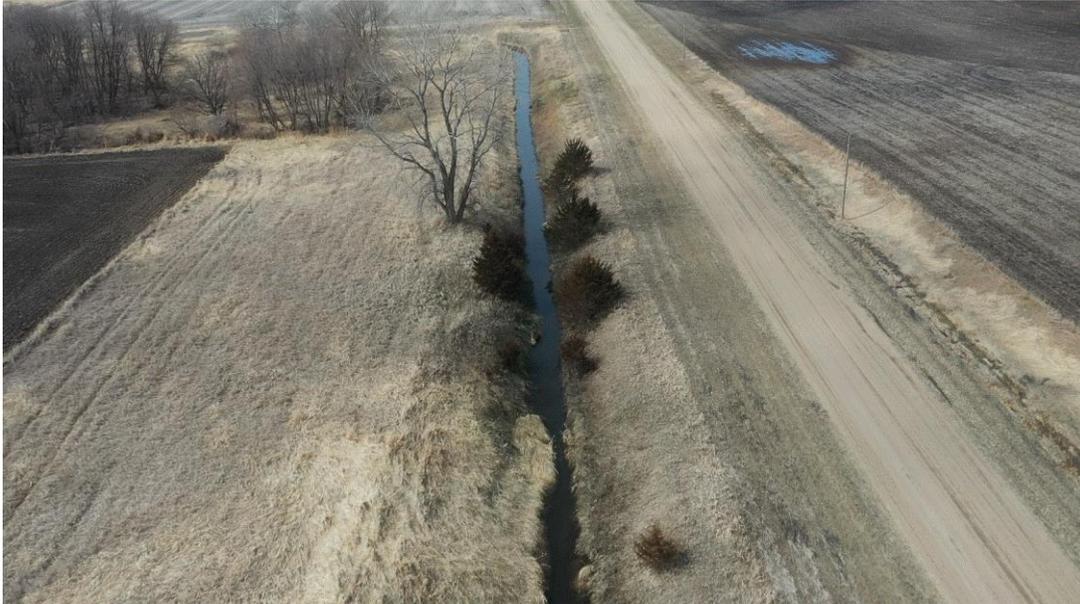
Figure 6: Trees on ditch banks and in buffer areas on Spur 2 open ditch at Sta. 86+00

Trees, brush, and shrubs were identified along the banks of the ditches throughout the watershed. To prevent future erosion of the ditch banks the present repair will include removing these obstructions. Areas where cleaning is to take place, vegetation and trees will need to be removed in order to access the ditch.

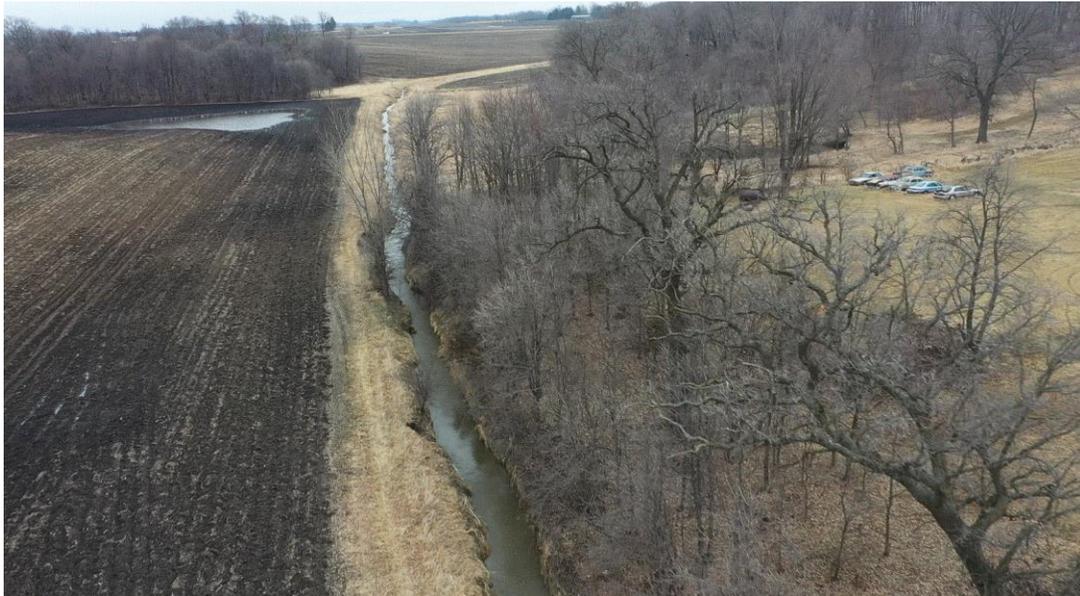
Figure 7: Trees within buffer on Spur 9 open ditch at Sta. 19+00

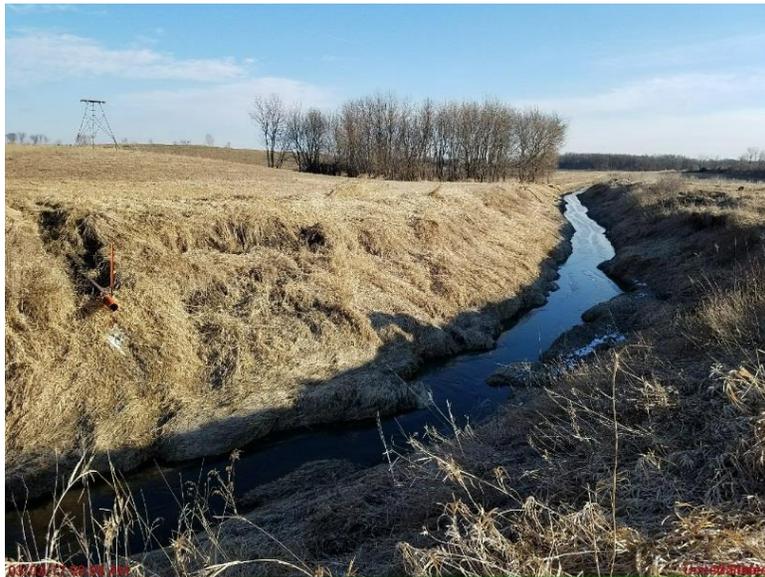
Many tile outlets within the open ditch are failing and causing or have the potential to cause erosion. Examples of failing tile outlets would include bent, broken, covered, crushed, or completely washed away tile outlets. Almost all tile outlets do not have riprap to protect the ditch banks.

Figure 9: Erosion at tile outlet

All tile outlets that enter a public open ditch may be considered for replacement or repair. Some of the tile outlets are in good shape and only require riprap protection. However, some tiles are bent, broken, or completely washed away causing erosion to the ditch banks. The repair of a damaged tile outlet will consist of replacing it with a section of new tile and placing riprap protection per the detail found in the Preliminary Repair Plans.

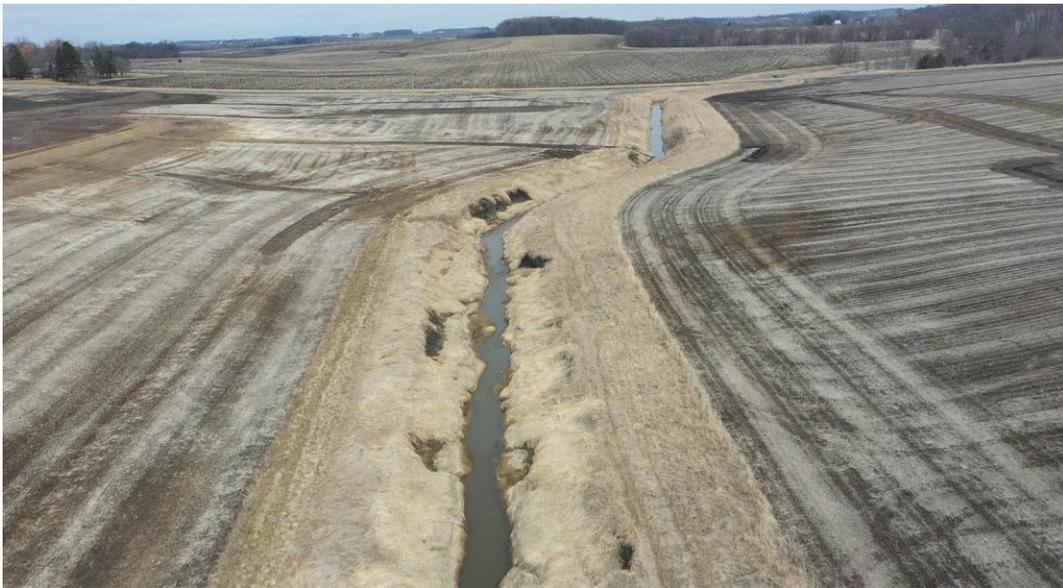
Figure 11: Sloughing on the Mainline open ditch at Sta. 313+00

The drone and topographic survey revealed significant ditch slope sloughing and erosion throughout the entire ditch system. Slough repairs included restoring the bank's side slope and stabilizing with erosion control blanket, mulch, or riprap. In some locations dewatering the side slope may be necessary to stabilize and may be necessary to include toe drains. Areas will be determined during construction.

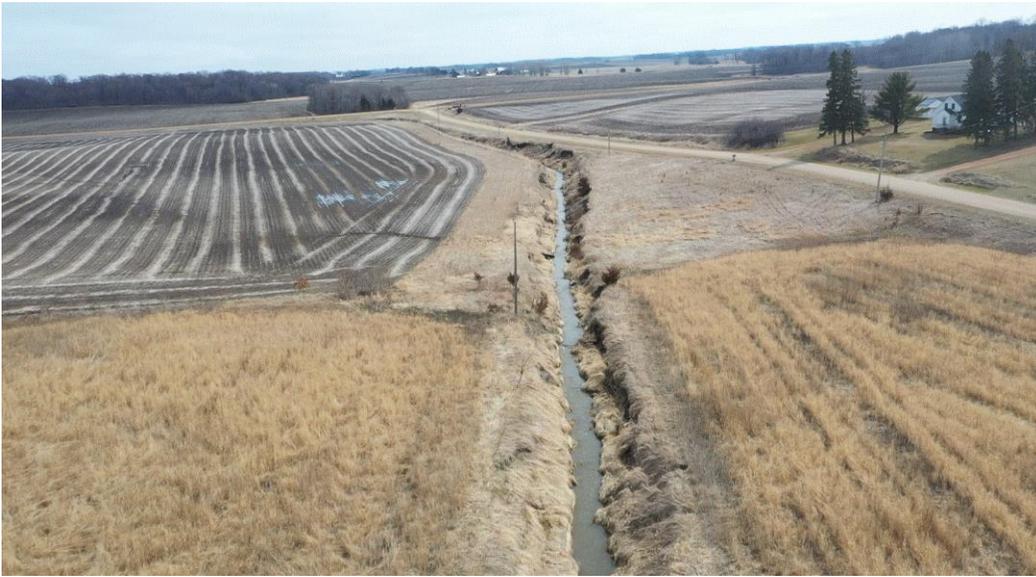
Figure 12: Sloughing on Spur 8 open ditch at Sta. 7+00

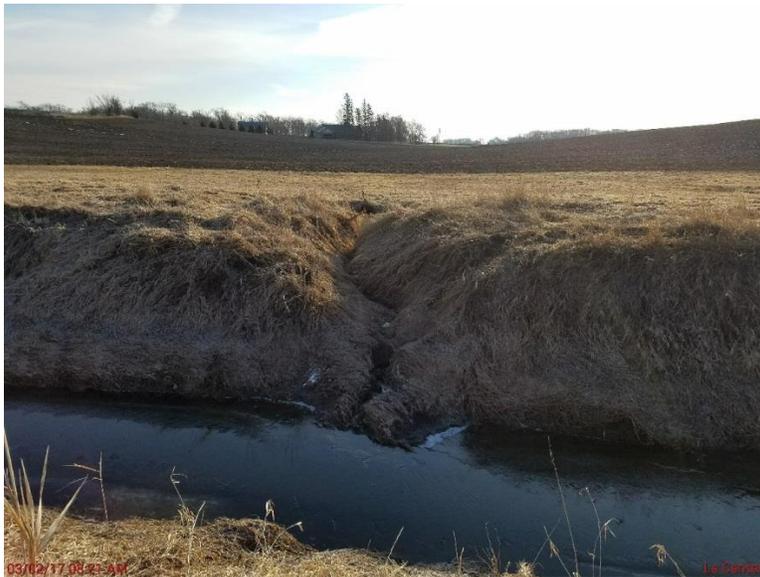
Gully erosion through the banks of the ditch was identified and is causing substantial deposition of sediment to the open ditch and adjacent landscape. Gully erosion occurs when runoff becomes concentrated and cuts through the ditch bank. These uncontrolled inlets become the avenue for sediment disposition in the ditch. Gully erosion can be seen in the figures below.

Figure 13: Gully erosion on Mainline open ditch in NW $\frac{1}{4}$ NW $\frac{1}{4}$ of Section 23 of Lexington Township

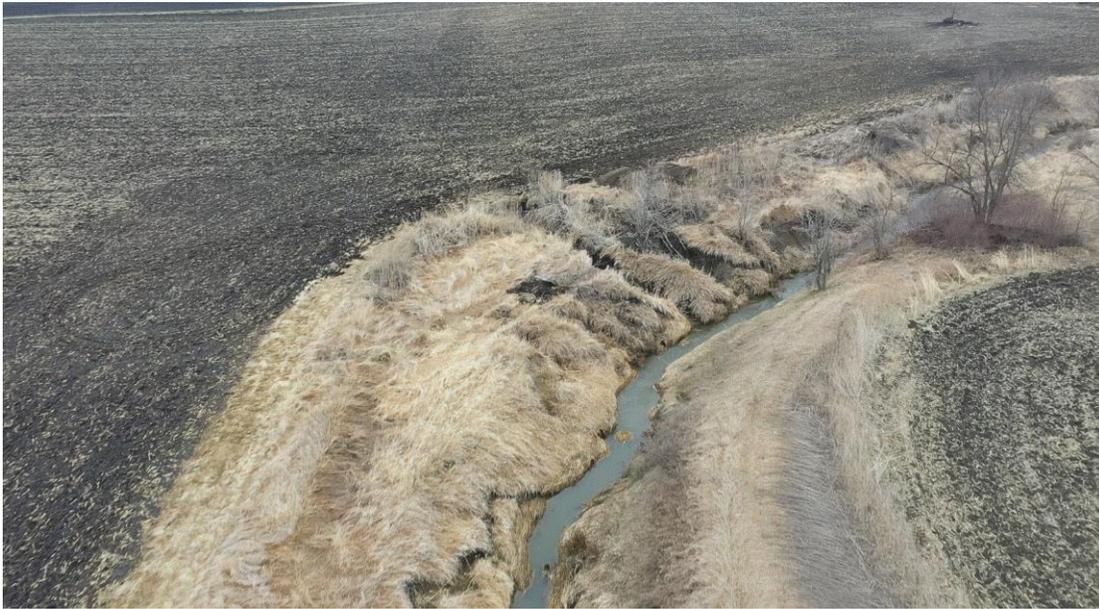
Figure 14: Bank washouts on Spur 9 open ditch at Sta. 60+00

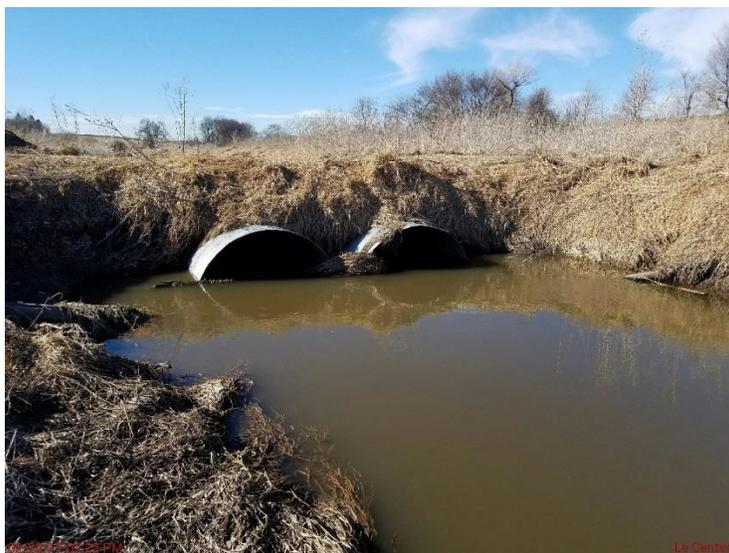
Figure 16: Erosion occurring around dual 84-inch culverts in NE 1/4 NW 1/4 of Section 28 of Lexington Township. (Crossing #6)

CD 23 has 36 culvert crossings, and many are in poor condition and have reached the end of their expected life use. Road crossings are recommended to be replaced in reinforced concrete pipe (RCP) with aprons on the upstream and downstream ends. In lieu of corrugated metal pipe (CMP) crossings, field and driveway crossings are recommended to be replaced with RCP or High-Performance Polypropylene Pipe (PP) for long-term durability and consideration of cost effectiveness. All culverts slated to be replaced will have seeding, erosion control, and riprap sized and placed on the upstream and downstream ends of culverts.

Not all culverts within the system are in poor condition and some will be left in place and maintained. Riprap will be placed on the upstream and downstream ends of the culverts left in place. Riprap will protect the culverts, roads, driveways, and field accesses from erosive flows, scouring, and downcutting. The riprap extents have been sized based off the expected peak flows to its location to ensure adequate protection.

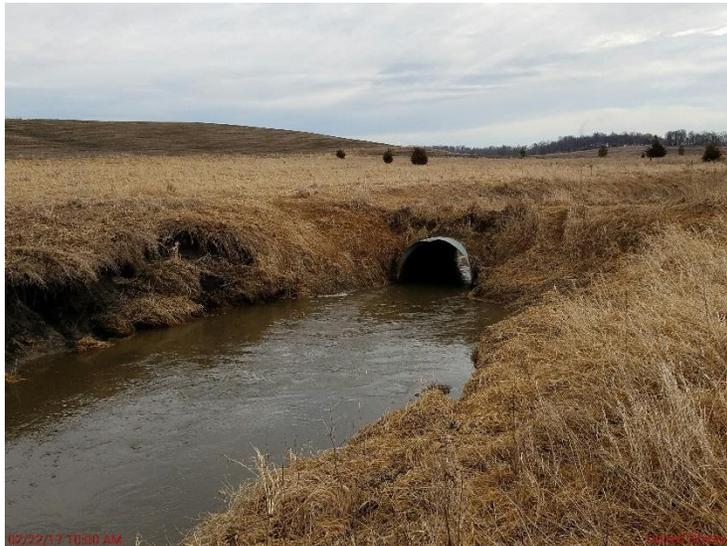
Figure 19: Sloughing on Main ditch in NW $\frac{1}{4}$ NE $\frac{1}{4}$ Section 27 of Lexington Township (Crossing #9)

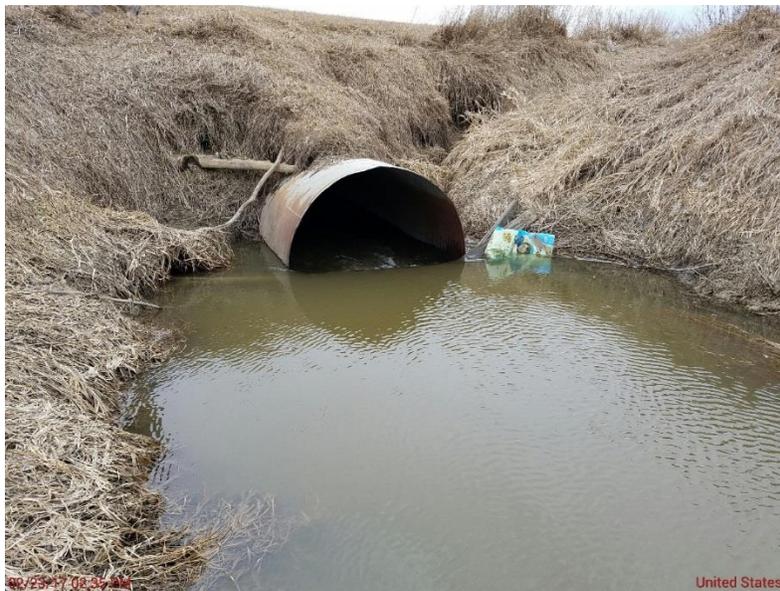
Figure 20: 72-inch culvert showing signs of erosion at County Road 125 crossing on Mainline. (Culvert #18)

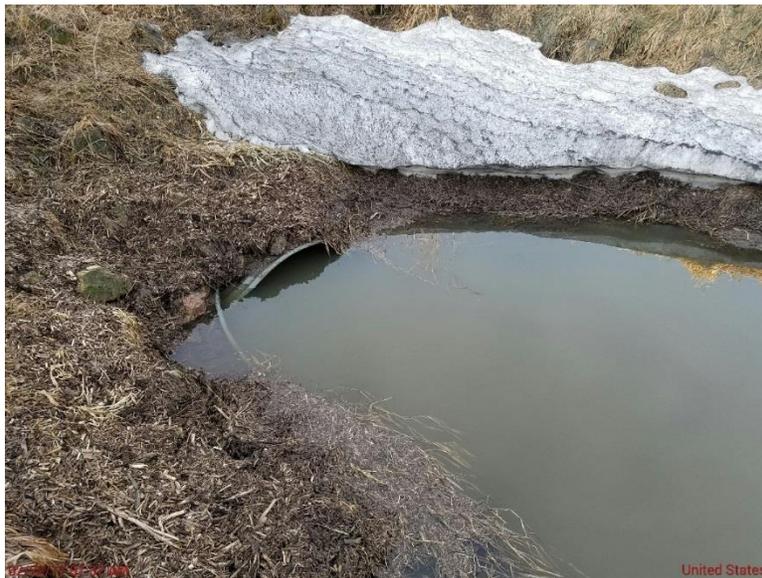
Figure 21: Restricted flow in 48-inch culvert in SW $\frac{1}{4}$ NW $\frac{1}{4}$ of Section 26 of Lexington Township on Spur 9 (Crossing #27)

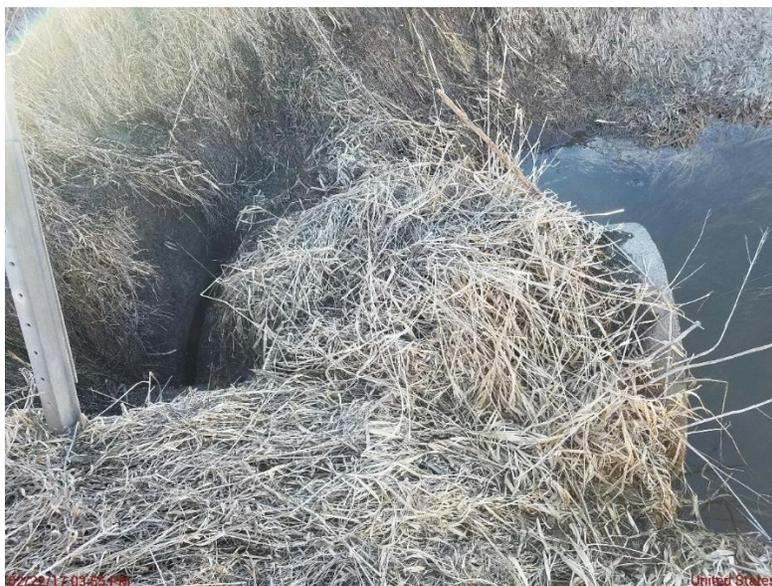
Figure 22: Separated joint in 42-inch culvert at Minnesota State Highway 99 crossing on Spur 9 (Culvert #30)

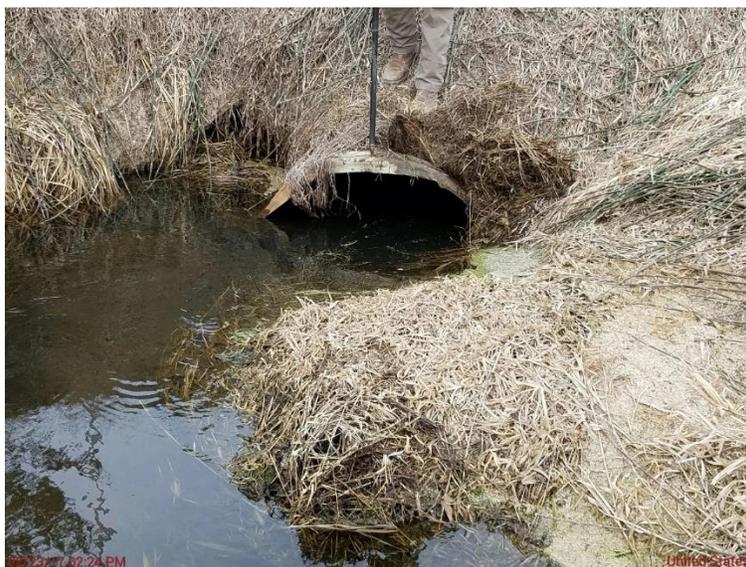
Figure 23: 48-inch Culvert showing signs of erosions the need for ditch cleaning at 376th Street crossing on Spur 2 (Culvert #37)

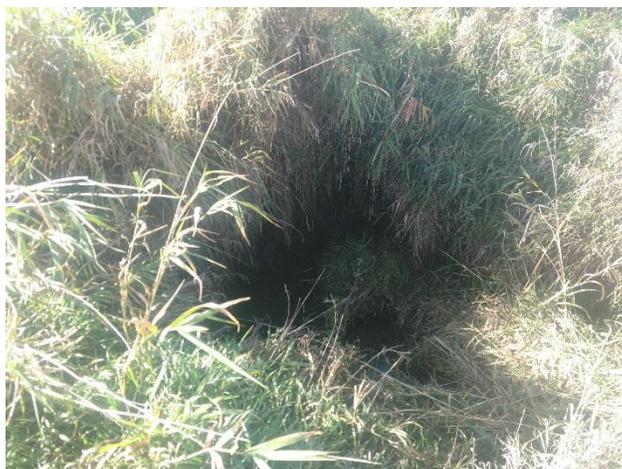
Mareks Lake, a public water under the jurisdiction of the Department of Natural Resources, is located at the upstream end of Spur 2. Currently there is a dilapidated 48-inch CMP drop structure that acts as the outlet for the lake. The structure is failing in many locations. Therefore, the lake is draining out at a lower elevation than as designed. The outlet pipe of the outlet structure is also broken. A large hole is also present near the outlet structure. The damaged structure is most likely the cause of the large hole. Figure 39 and Figure 40 illustrate the current condition of the outlet structure and hole. Minnesota DNR completed a survey report in December 2017 which established an Ordinary High Water (OHW) elevation at 1045.66 NAVD 88 (1045.66 NGVD 29).

Figure 40: Large hole adjacent to Mareks Lake outlet structure
